ROUTE 1 CORRIDOR STUDY

FINAL REPORT

From North of Route 3 (William Street) to Princess Anne Street / Hanson Avenue

November 18, 2020

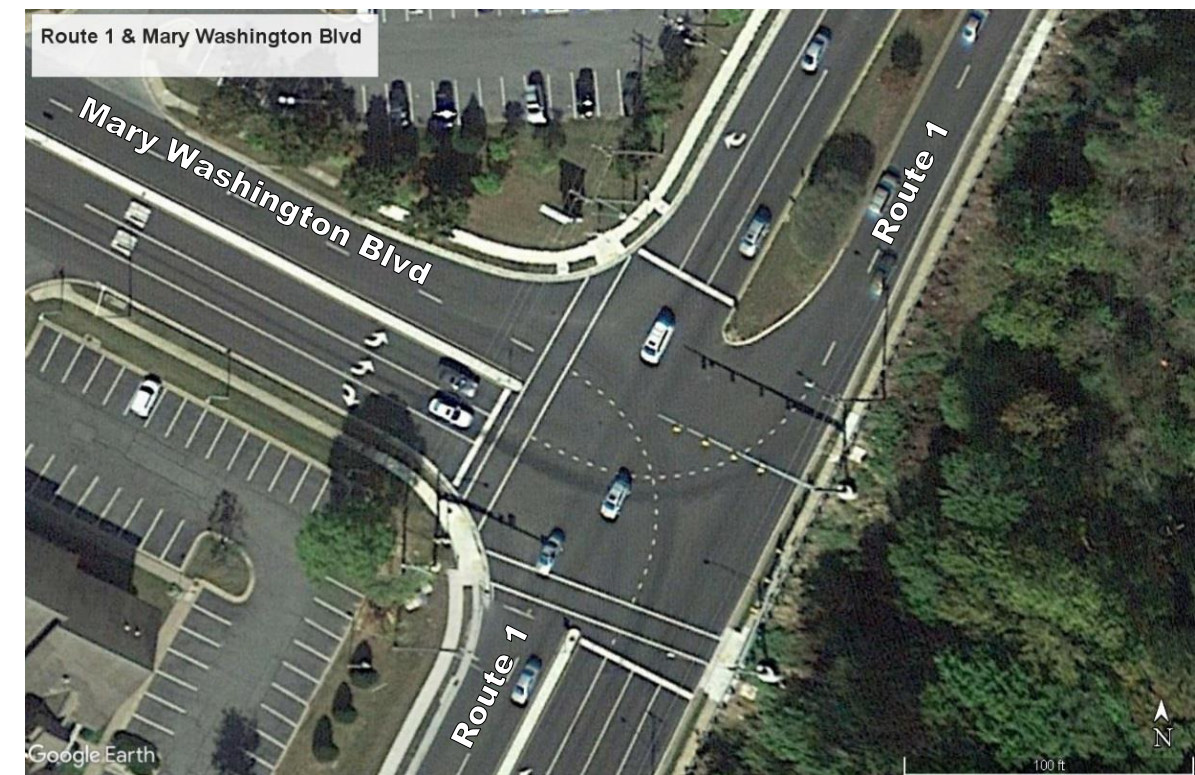
Figure 4: Route 1 at Mary Washington Boulevard

Mary Washington Boulevard is classified as Minor Collector per *VDOT Functional Classification*. The intersection of Route 1 at Mary Washington Blvd is currently a 3-leg signalized T-intersection. The posted speed limit for Mary Washington Blvd is 35 miles per hour. The northbound approach of Route 1 has two left-turn lanes and two through lanes. The southbound approach has two through lanes and one right-turn lane. The eastbound approach of Mary Washington Blvd has two left-turn lanes and one right-turn lane. The signal operations include protected lefts for the northbound approach, with the eastbound rights overlapping with the northbound lefts and the southbound rights overlapping with the eastbound lefts. The northbound/southbound through movements are coordinated with adjacent signalized intersections. Pedestrian facilities (crosswalks, pedestrian signals) are provided for the northbound and eastbound approaches. **Figure 4** shows an aerial of the intersection.

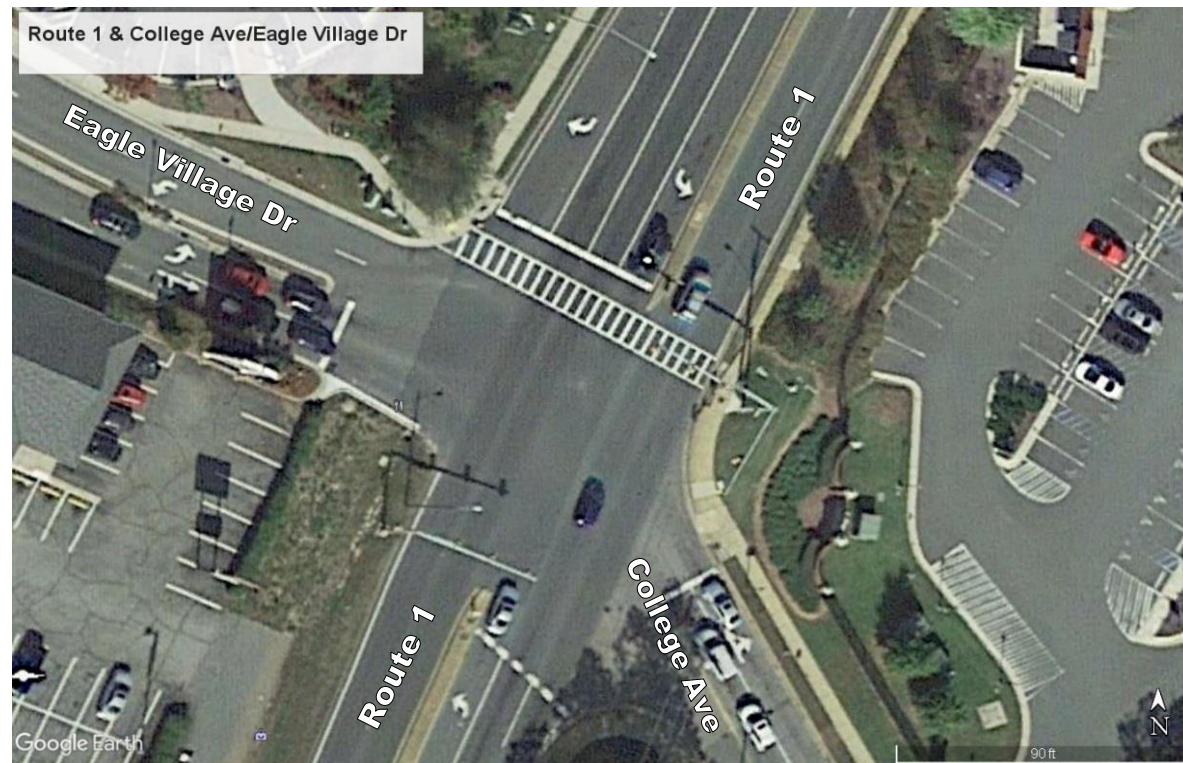
Figure 5: Route 1 at Route 1 College Avenue / Eagle Village Drive

College Avenue is classified as Major Collector per *VDOT Functional Classification*. The intersection of Route 1 at College Avenue / Eagle Village Drive is currently a 4-leg signalized intersection. The posted speed limit for College Avenue and Eagle Village Drive is 25 miles per hour. The northbound approach of Route 1 has one left-turn lane, one through lane, and one shared thru-right lane. The southbound approach has one left-turn lane, two through lanes, and a right-turn lane. The eastbound approach of Eagle Village Drive has one left-turn lane and one shared thru-right lane. The westbound of College Avenue approach has one left-turn lane and one shared thru-right lane. The signal operations include permitted/protected lefts for the northbound approach, protected lefts for the southbound approach, and split phasing for the eastbound and westbound approaches. The northbound/southbound through movements are coordinated with adjacent signalized intersections. Pedestrian facilities (crosswalks, pedestrian signals) are provided for the southbound approach. **Figure 5** shows an aerial of the intersection.

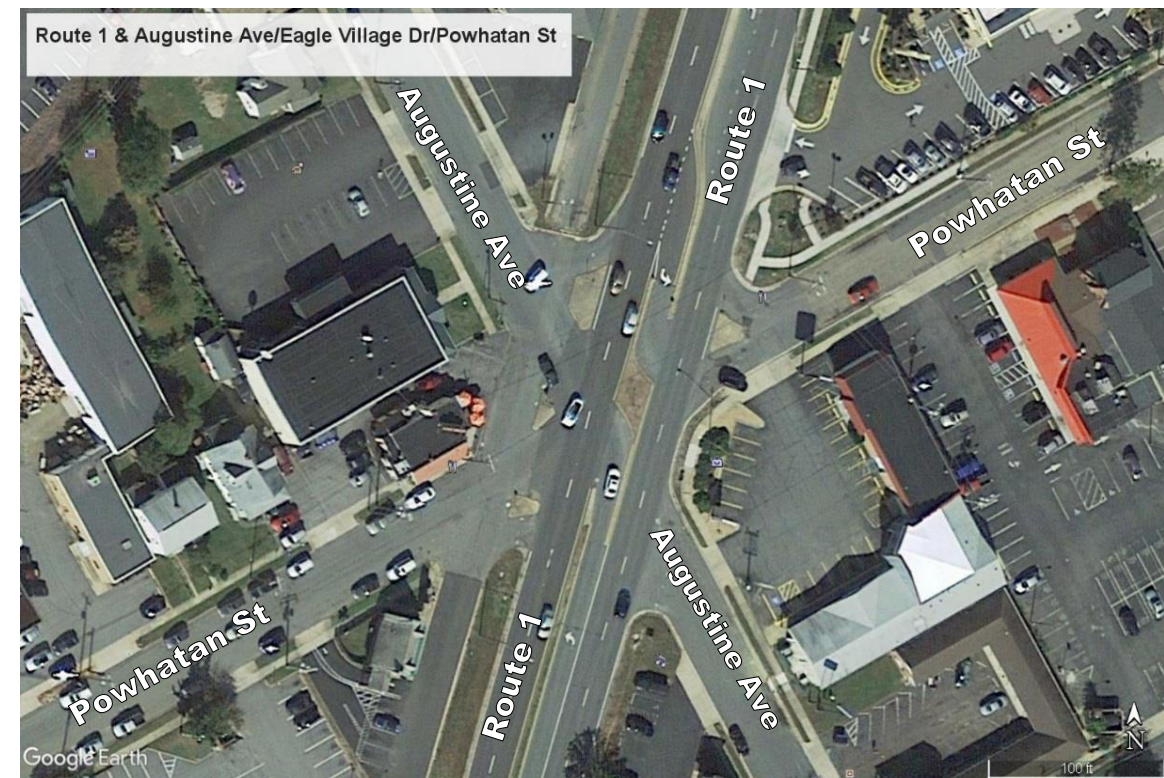
Figure 6: Route 1 at Augustine Avenue / Powhatan Street

The intersection of Route 1 at Augustine Avenue / Powhatan Street is currently a 6-leg unsignalized intersection, with a service road running parallel to Route 1 to the west. Augustine Avenue, Eagle Village Driveway, and Powhatan Street are stop controlled while Route 1 is free-flow. Powhatan Street is classified as a Minor Collector per *VDOT Functional Classification*. There are no posted speed limits along these side roads. The northbound approach of Route 1 has one left-turn lane (hard left and soft left), one through lane, and one shared thru-right lane. The southbound approach has one hard left-turn lane, two through lanes, and one hard right-turn lane. The eastbound approach of the service road has one hard right-turn lane. The northwest approach of Augustine Avenue has one right-turn lane (hard right and soft right). The westbound approach of Powhatan Street has one hard right-turn lane. The southeast approach of Augustine Avenue has one right-turn lane (hard right and soft right). Pedestrian facilities (crosswalks, pedestrian signals) are not currently provided at this intersection. **Figure 6** shows an aerial of the intersection.

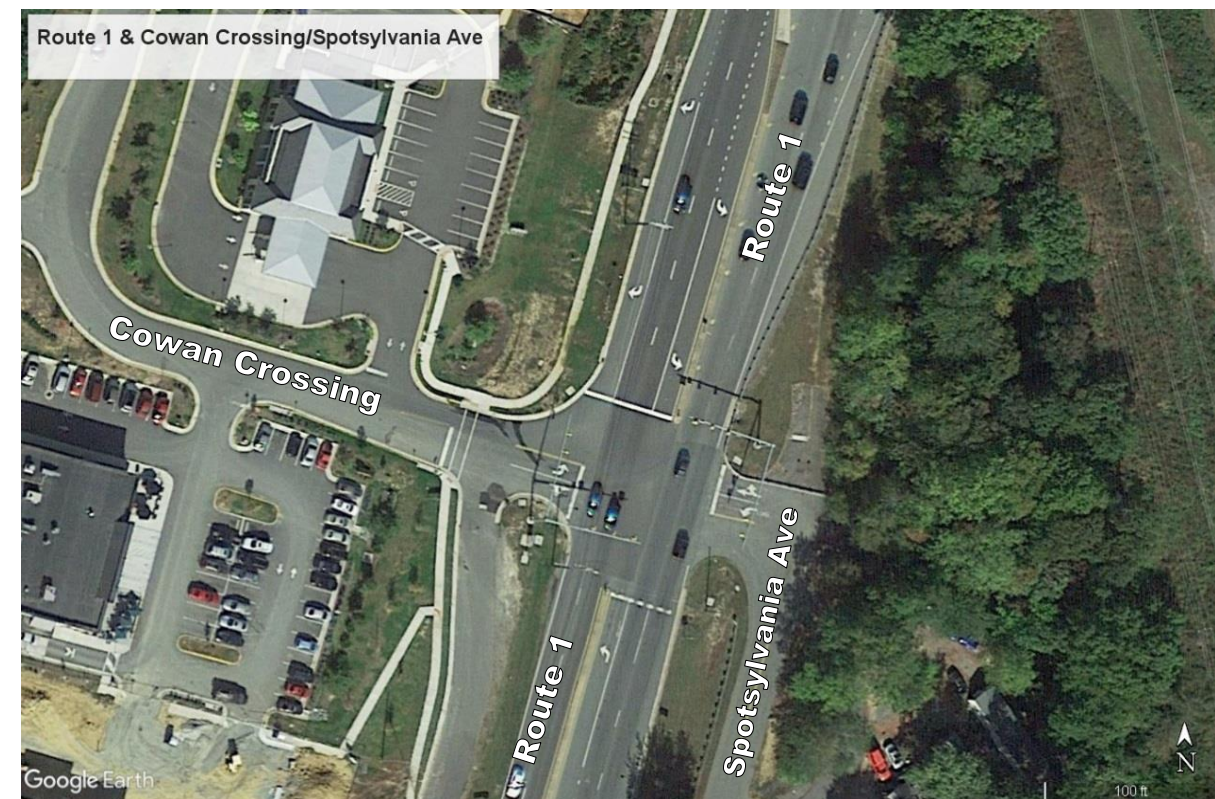
Figure 8: Route 1 at Cowan Crossing / Spotsylvania Avenue

The intersection of Route 1 at Cowan Crossing / Spotsylvania Avenue is currently a 4-leg signalized intersection. The northbound approach of Route 1 has one left-turn lane, one through lane, and one shared thru-right lane. The southbound approach has one left-turn lane, two through lanes, and one right-turn lane. The eastbound approach of Cowan Crossing has one left-turn lane and one thru-right lane. The westbound approach of Spotsylvania Avenue has one left-turn lane and one thru-right turn lane. The signal operations include permitted/protected lefts for the northbound and southbound approaches and split phasing for the eastbound and westbound approaches, with the southbound rights overlapping with the eastbound approach. The northbound/southbound through movements are coordinated with adjacent signalized intersections. Pedestrian facilities (crosswalks, pedestrian signals) are currently not provided for this intersection. **Figure 8** shows an aerial of the intersection.

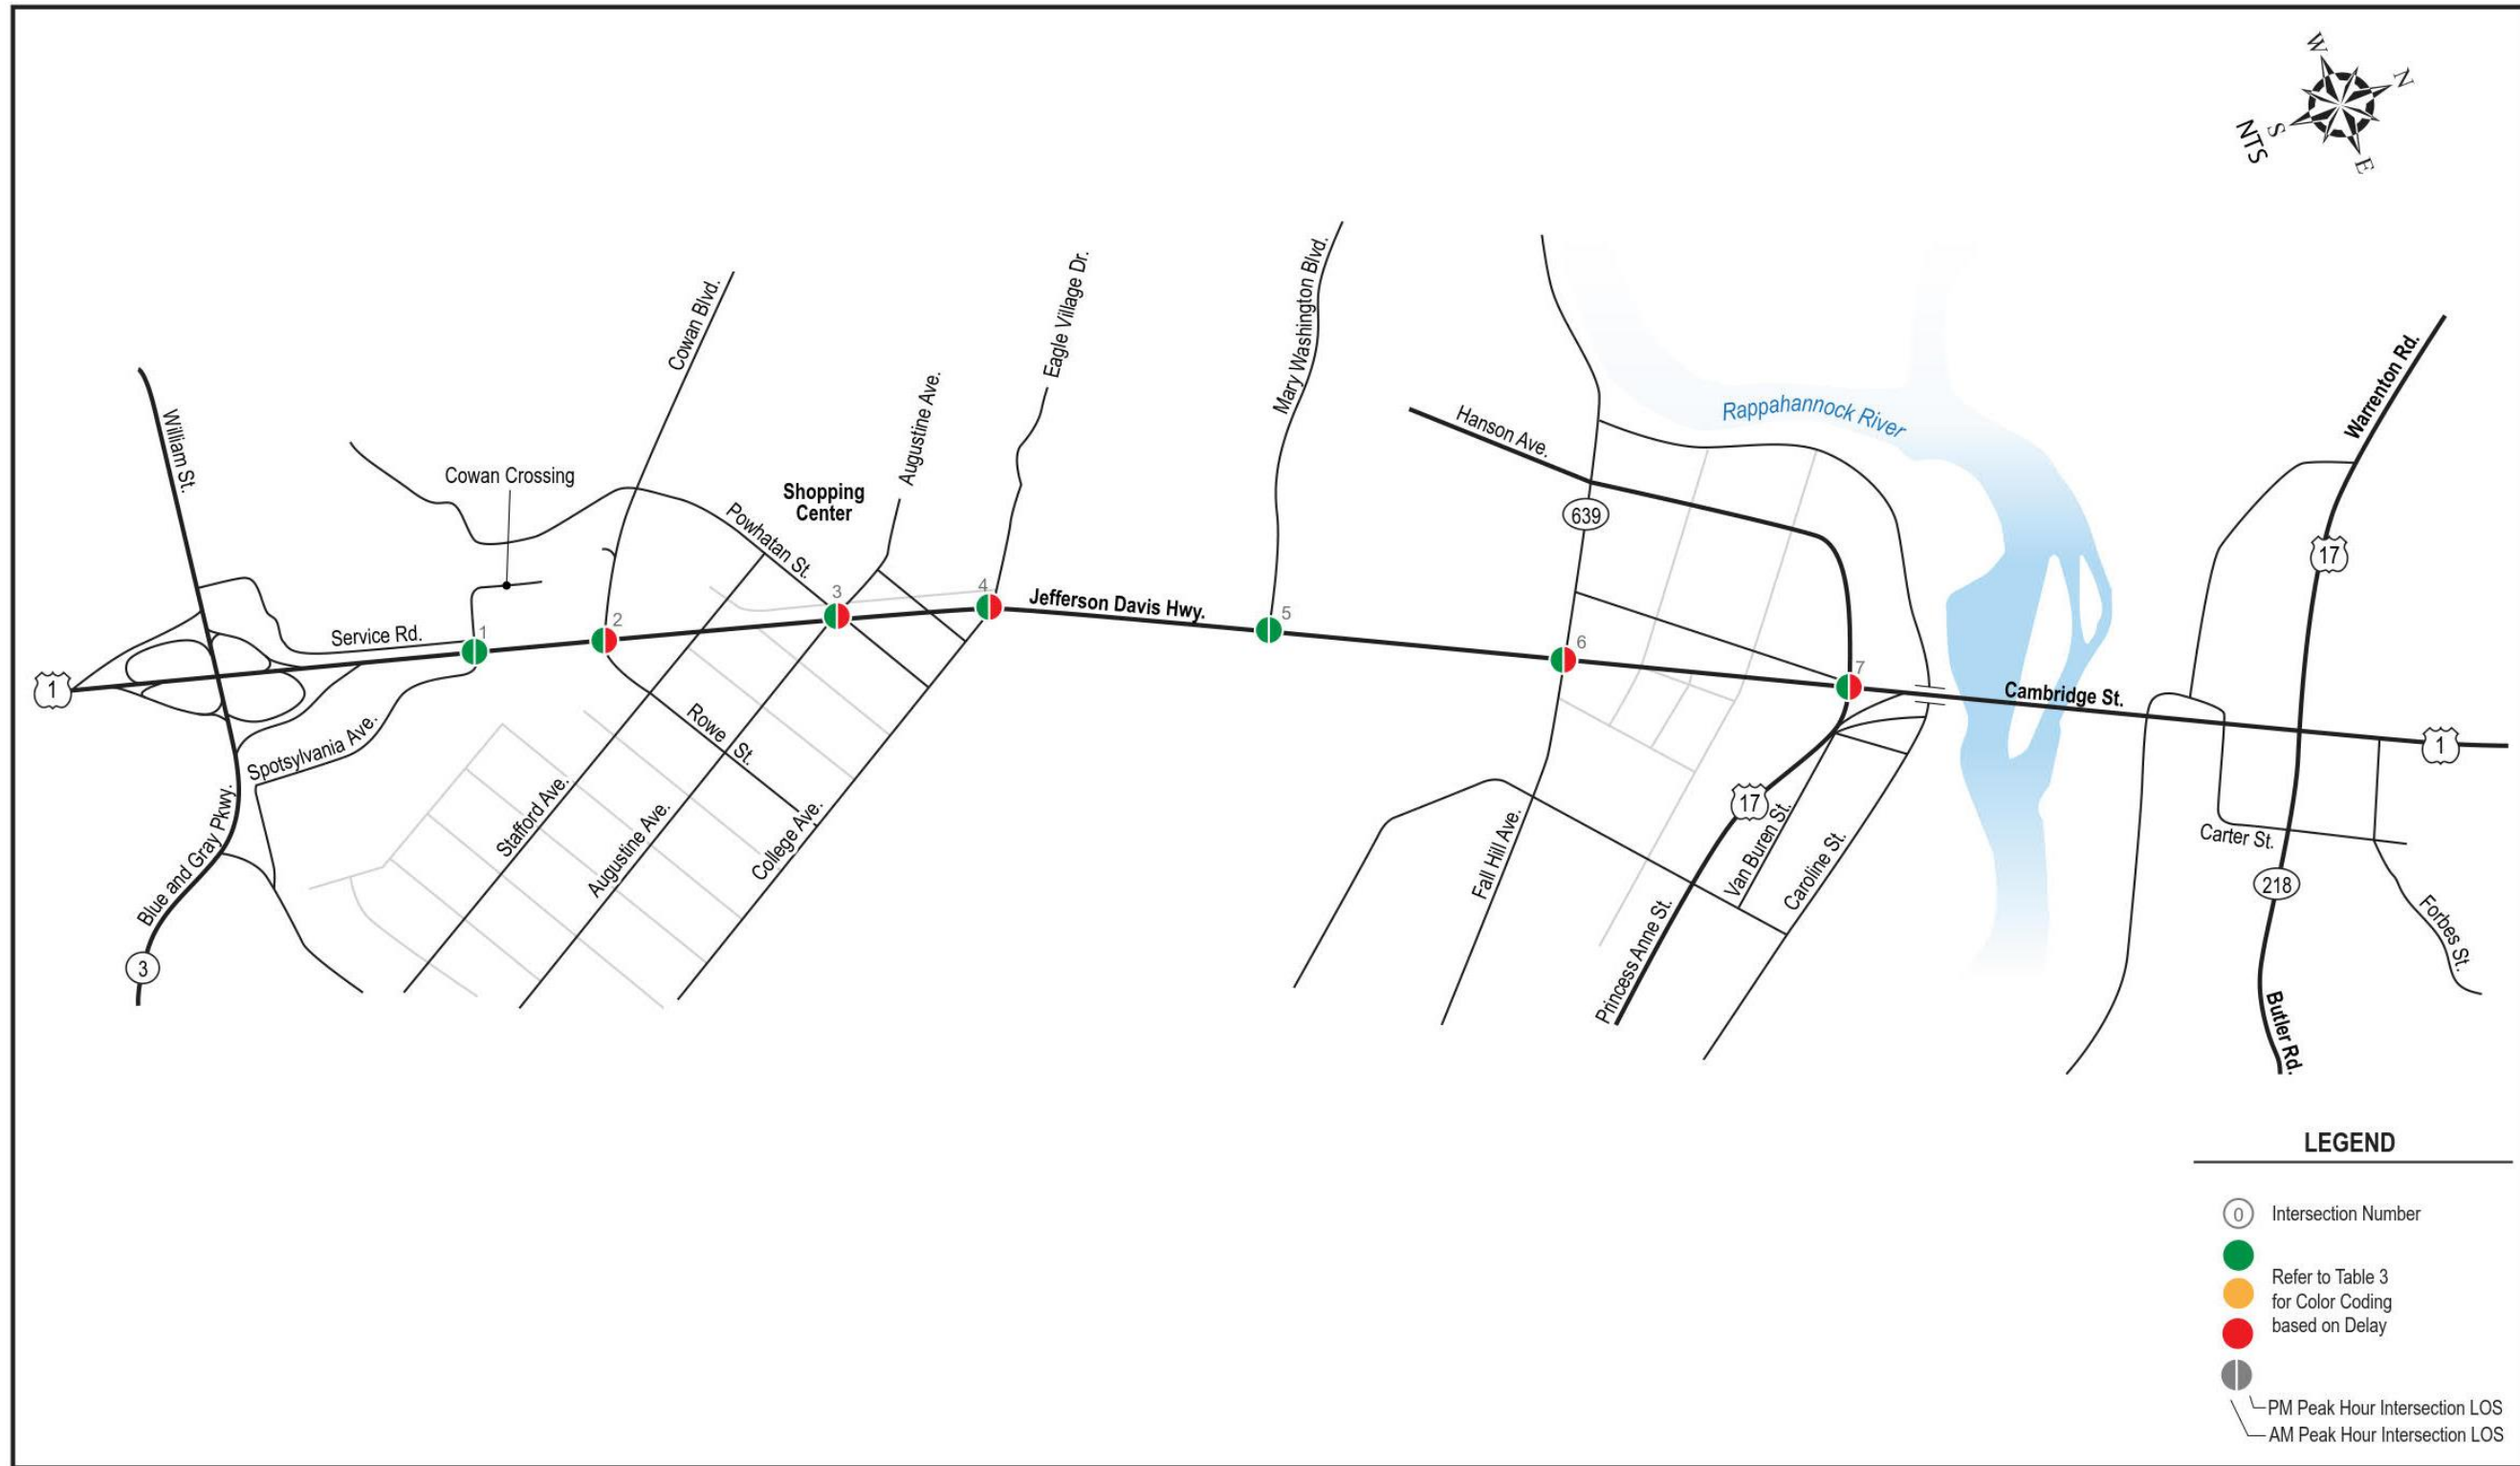
Figure 12. Future 2030 No Build AM (PM) Peak Hour Intersection Operations Results

Operational analysis was performed at each of the study intersections for the 2030 Future No-Build Conditions scenario. **Table 8** provides a summary of the average AM and PM peak hour delay for each movement for the study intersections along the study corridor.

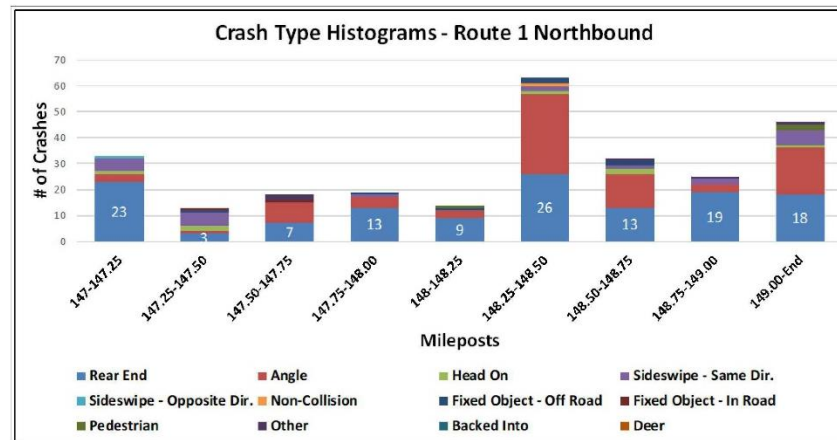
Figure 20. Crash density histograms per ¼-Mile (Route 1 Northbound).

Crash density histograms were developed in ¼-mile increments to provide a visual representation of crashes along the corridor based on crash type, crash severity, time-of-day, and roadway conditions. The Route 1 histograms were separated into northbound and southbound directions. Crash hot spots were identified along the corridor as locations with the highest crash density. As shown in Figure 20, three (3) crash hotspots were identified for Route 1 Northbound: 1) Spotsylvania Avenue intersection, 2) between Fall Hill Avenue and Charles Street, and 3) Warrenton Road intersection. As shown in Figure 21, three (3) crash hotspots were identified for Route 1 Southbound: 1) between Augustine Avenue and College Avenue, 2) between Fall Hill Avenue and Charles Street, and 3) Warrenton Road intersection. A discussion of the crash hotspots for the northbound and southbound directions is provided below.

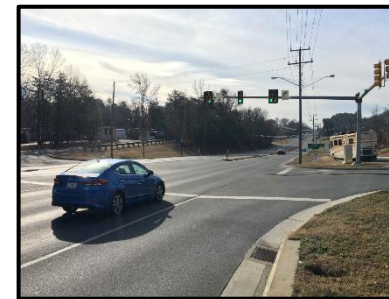
Figure 23

- The northbound and southbound approaches do not provide overhead mast arm sign panels indicating “Spotsylvania Avenue” to approaching vehicles (Figure 23). (See Recommendation A3)

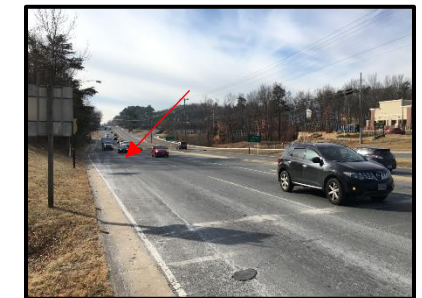
Figure 24

- Westbound State Route 3 to northbound Route 1 provides no merging or yield pavement markings (Figure 24). Additionally, no merging sign panel (W4-2) is provided to indicate that the State Route 3 westbound receiving lane along northbound Route 1 is ending. This merging sign panel is not a requirement; however, it could be beneficial to northbound vehicles at the merge point of westbound Route 3 and northbound Route 1. According to the collision diagrams, rear-ends and side-swipe crashes were prominent from 2013 through 2016. (See Recommendation A6)

- A6. Consider installing merging sign panel (W4-2) along the east side of the road at the merge point of westbound Route 3 ramp and northbound Route 1 through lanes.

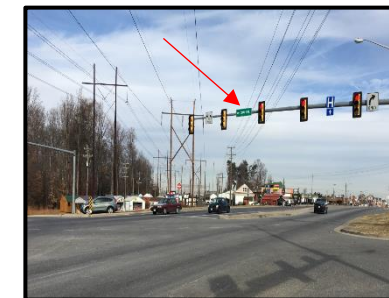
Figure 25

- The northbound and southbound approaches provide a “Cowan Boulevard” street sign on the mast arm, however the lettering height on this street sign may not meet MUTCD guidance as listed in Table 13 (Figure 25). In 2015, according to the collision diagrams, rear-end crashes were prominent, and the legibility of these overhead street name plates could have contributed to these statistics. (See Recommendation A10)

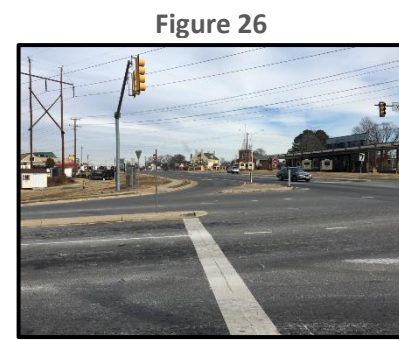
Figure 26

- The eastbound right-turn lane left sight distance is obstructed due to the location of the eastbound left-turning and through lane stop bars (**Figure 26**). Additionally, the horizontal layout in combination with the mast arm pole and traffic signal box (on the northwest corner) provides an obstructed view for eastbound right-turning vehicles. During the PM peak hour, vehicles were observed making unsafe right-turn movements to southbound Route 1 due to the current stop bar location. Based on collision diagrams, rear-end crashes (along the south leg of the intersection) and angle crashes occurred in 2012, 2013, and 2015, which could be attributed to this current layout for eastbound right-turning vehicles. (See Recommendation A11)

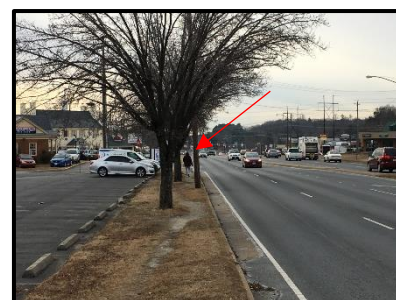
Figure 28

- Sidewalk discontinuity appears to be an issue on both the west and east sides of Route 1, forcing pedestrians to walk on either grass paths and/or frontage road. Additionally, no pedestrian facilities (e.g., crosswalks and ramps) are provided along this stretch for pedestrians to cross Route 1. During the PM peak hour, several pedestrians were observed crossing Route 1 mid-block (**Figure 28**). (See recommendation A13)
- Pavement striping along the northbound lanes is faded. (See recommendation A14)

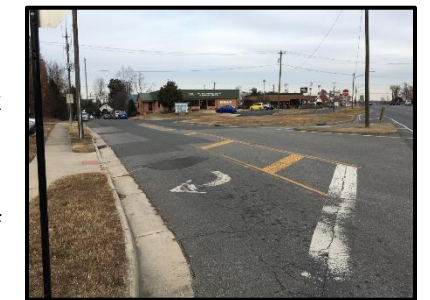
Figure 29

- The eastbound pavement markings at the Route 1 at Stafford Avenue unsignalized intersection are faded. (See recommendation A15)
- Currently, sporadic pedestrian facilities are provided at the eastbound approach at the Route 1 at Stafford Avenue unsignalized intersection. A pedestrian ramp, with an ADA standard compliant tactile dome, is provided on the southwest corner of the intersection, however no crosswalk is provided. Additionally, given the offset location of the southwest corner ramp, a crosswalk would be leading pedestrians into eastbound and westbound traffic along this road. A porkchop raised median is provided for southbound right-turning vehicles and provides ramps (without ADA compliant tactile domes) and a crosswalk through the channelized turn, from the northwest corner to the porkchop median. An additional ramp (without ADA compliant tactile

domes) is provided, in the porkchop, for pedestrians attempting to cross Route 1, however no crosswalk is provided and a raised median dividing northbound and southbound traffic prevents pedestrians from crossing the road safely (**Figure 29**). (See recommendation A13)

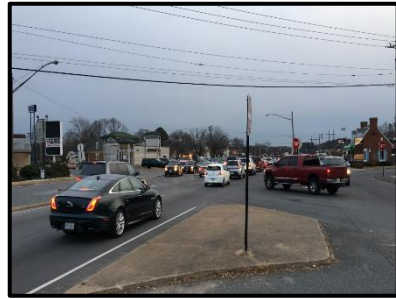
Figure 31

▪ The frontage road adjacent to the unsignalized intersection of Route 1 at Augustine Avenue/Powhatan Street, on the west side of the road, is disorganized. Multiple points of entry create multiple conflict points for northbound left-turning vehicles, southbound right-turning vehicles, eastbound right turning vehicles, and northbound/southbound vehicles traveling along the frontage road. This scenario, in combination with southbound vehicle queues from the intersection of Route 1 at Cowan Boulevard created several near-miss incidents (Figure 31). (See recommendation A20)

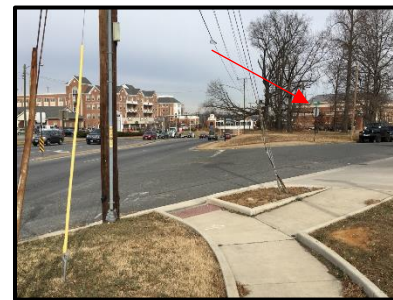
Figure 32

▪ The Route 1 at Snowden Street sign post is currently placed approximately 20 feet east of the intersection, adjacent to the northeast corner. This location makes visibility difficult for vehicles traveling northbound. Additionally, there is a “Stop” sign panel (R1-1) located on this same street sign post that is approximately 15 feet east of the westbound stop bar (Figure 32). (See Recommendation A23)

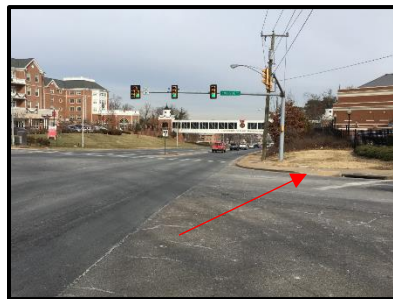
Figure 33

▪ Currently, pedestrian ramps (with non-compliant ADA tactile domes) are provided across the east leg, but are placed approximately 10 feet east of the intersection along College Avenue (Figure 33). Additionally, neither a countdown timer nor pedestrian crosswalk is provided across the east leg of the intersection. Despite having some pedestrian features for crossing the east leg, the northbound approach does not provide “Turning Vehicles Yield to Pedestrians” sign panel (R10-15) on mast arm or along east side of the road along northbound approach. (See Recommendation A26)

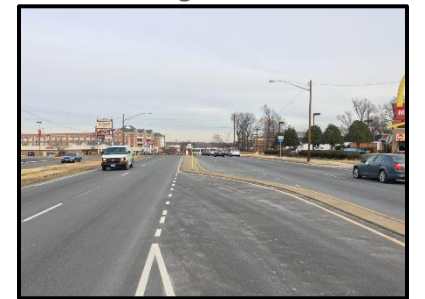
Figure 35

▪ The northbound approach to the intersection has vertical curvature associated with it. Vehicles traveling northbound begin to descend downhill approximately 500 feet prior to the intersection (Figure 35). According to the collision diagrams, rear-end collisions occurred more often in 2015 and 2016. Vertical and horizontal alignment of the road may be causing some of these collisions. (See Recommendation A29)

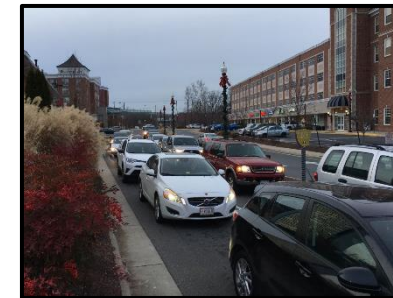
Figure 36

▪ During the PM peak hour, eastbound vehicle queues were observed extending back to the unsignalized intersection within the Eagle Village Shopping Center (Figure 36). These queues may be due to the shared roadway utilized by the East Village shopping center, business park, and Mary Washington Hospital users.

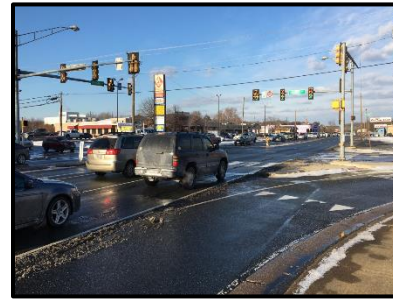
Figure 37

- The signal heads at the Route 1 at Mary Washington Boulevard intersection have backplates, but do not have yellow retroreflective borders installed (Figure 37). (See Recommendation A35)

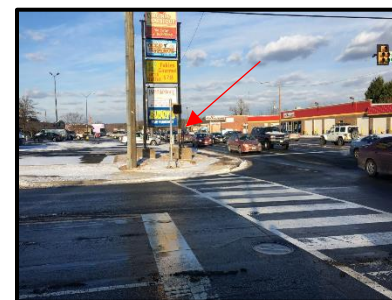
Figure 38

- The northbound pavement markings are faded. (See Recommendation A38)
- The eastbound right turn movement left sight distance is obstructed due to commercial signage, traffic control box, and mast arm pole (Figure 38). Please note, relocating the existing commercial signage and traffic control related features is not a feasible low-cost improvement; however, it should be known that the limited left-sight distance due to these obstructions could be contributing to the angle crashes and rear-end crashes along the south leg.

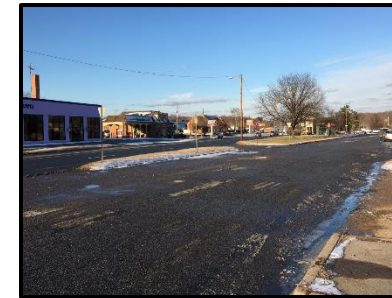
Figure 39

- Several commercial driveways exist along the east and west sides of the road, particularly between the unsignalized intersections of Route 1 at Welford Street and Route 1 at Charles Street (Figure 39). These unsignalized intersections create obscure vehicle movements based on their existing alignment relative to the Route 1 corridor mainline. Based on the collision diagrams, angular crashes and rear-end crashes were prominent from 2012 through 2014, as well as in 2015, and may be attributed to the layout currently in place. (See Recommendation A40)

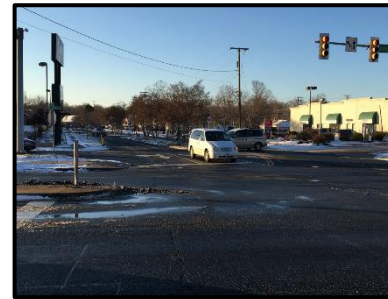
Figure 41

- Pedestrian ramps (with ADA non-compliant tactile domes) are provided on the southeast and southwest corners of the intersection; however, no ramps are provided on the northwest and northeast corners. Additionally, no pedestrian facilities are provided for any legs of the intersection (Figure 41). (See Recommendation A48)

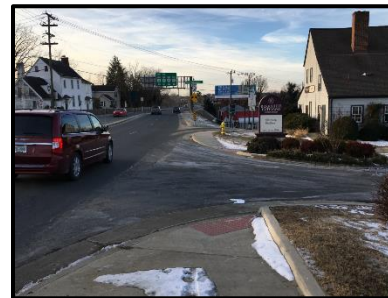
Figure 42

- The westbound approach at the unsignalized intersection of Route 1 at Carter Street does not provide a stop bar or pedestrian crosswalk. (See Recommendation A49)
- The southbound right turn lane at the unsignalized intersection of Route 1 at West Cambridge Street does not provide a pedestrian crosswalk (Figure 42). (See Recommendation A50)
