ROUTE 15 (SOUTH MAIN STREET) CORRIDOR STUDY

FINAL REPORT

From US 460 to Griffin Boulevard

December 2018

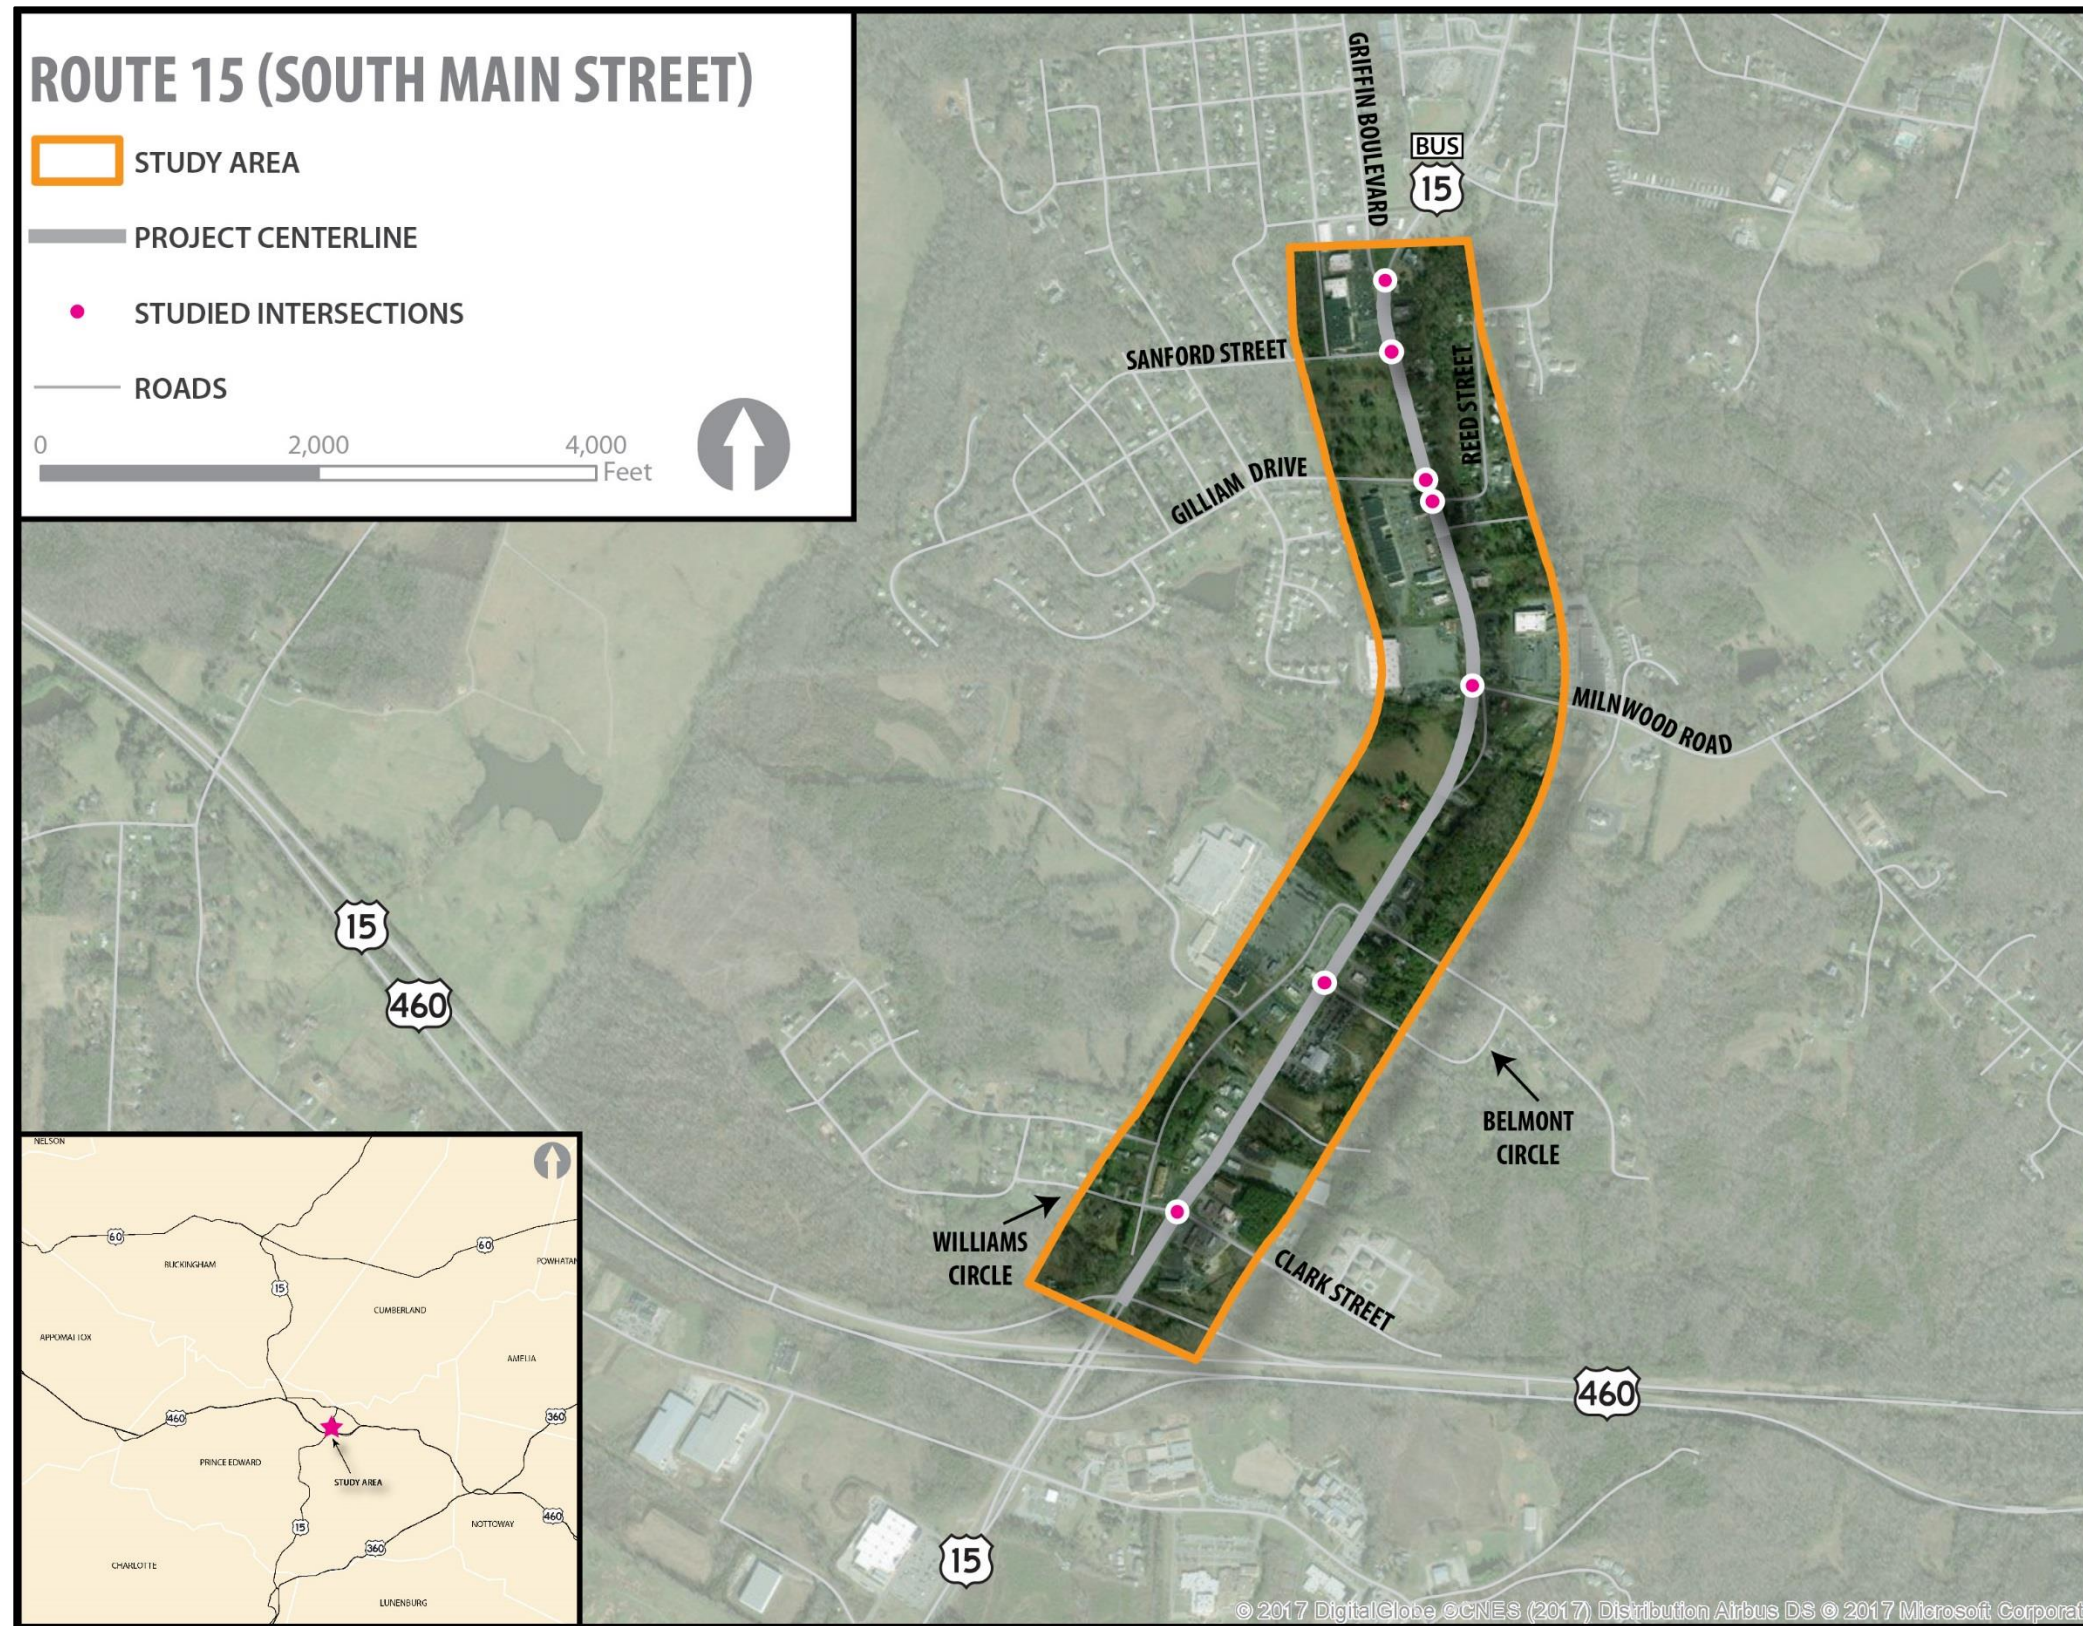
Figure 1. Study Area Map

1. Route 15 and Griffin Boulevard
2. Route 15 and Sanford Street
3. Route 15 and Gilliam Drive
4. Route 15 and Reed Street
5. Route 15 and Milnwood Road
6. Route 15 and Belmont Circle
7. Route 15 and Clark Street

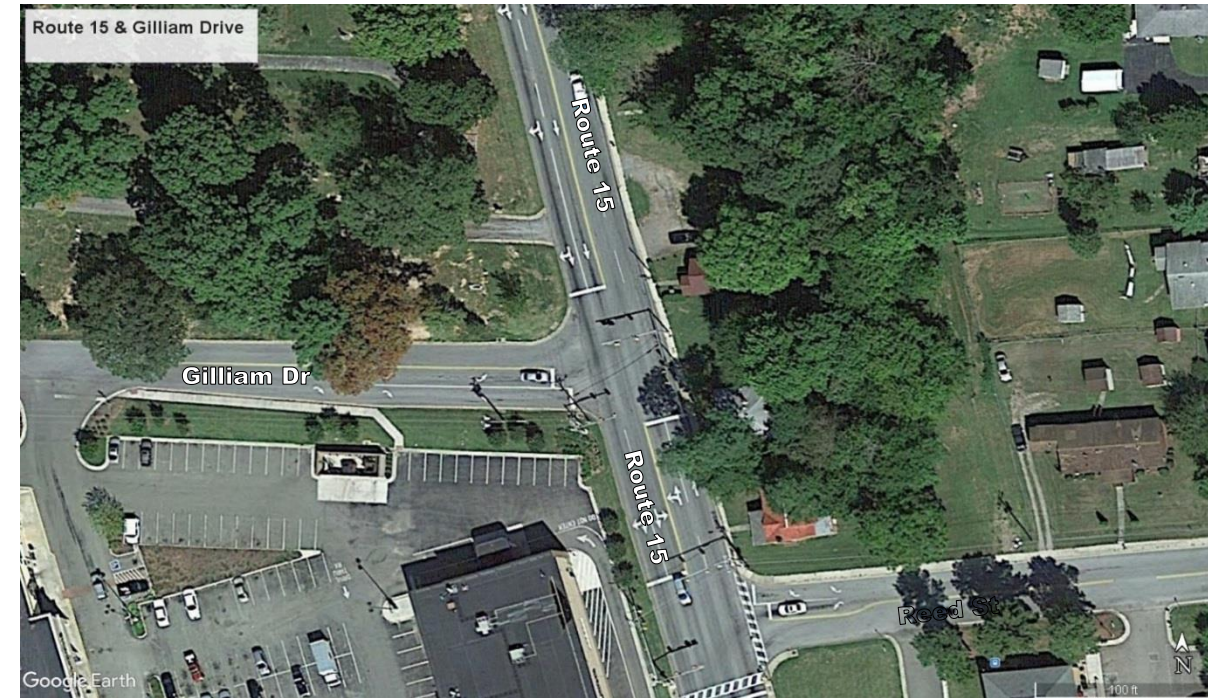
Figure 4: Route 15 at Gilliam Drive

The intersection of Route 15 at Gilliam Drive is a signalized T-intersection. The speed limit for Gilliam Drive is 25 miles per hour. The northbound approach of Route 15 has one shared left-thru lane and one through lane. The southbound approach has one through and one shared through-right lane. The eastbound approach of Gilliam Drive has one left-turn lane and one right-turn lane. The signal operations include a permitted left-turn northbound. Pedestrian facilities (crosswalks, pedestrian signals) are currently not provided at this intersection. **Figure 4** shows an aerial of the intersection.

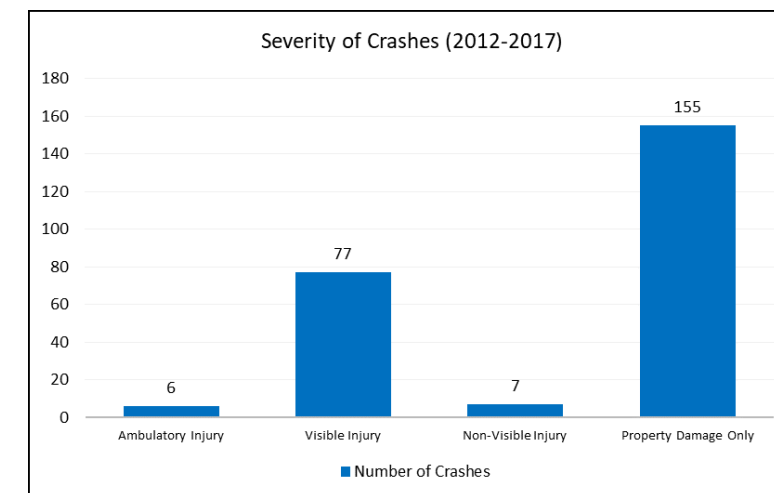
Additionally, **Figure 14** shows that 6 ambulatory injuries (3%), 7 non-visible injuries (3%) and 77 visible injuries (31%) occurred in the study area within the five-year period. The majority of crashes that occurred were property damage, which accounted for 63% of all crashes. **Figure 15** provides a crash density map of the overall corridor.

Figure 14. Severity of crashes for the project study area.

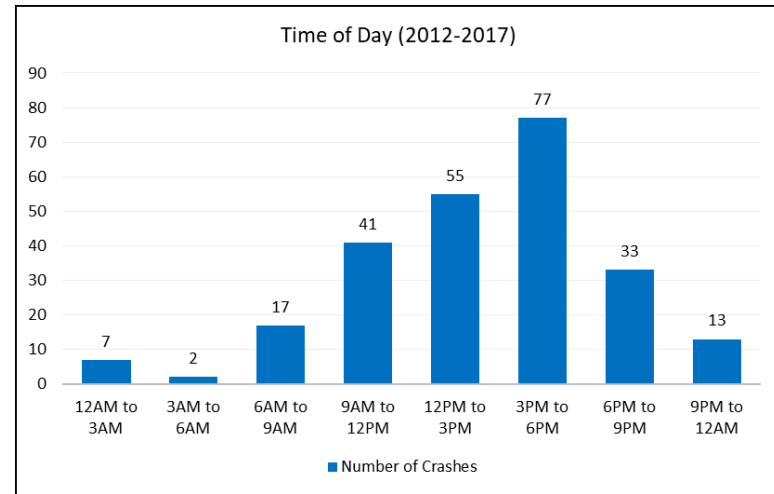
Figure 16 displays the number of crashes that occurred by time of day, presented in 3-hour increments. The highest frequency of crashes occurred from 3PM–6PM (31%), from 12PM–3PM (22%), from 9AM–12PM (17%), and from 6PM–9PM (13%).

Figure 16. Number of crashes by time of day for the project study area.

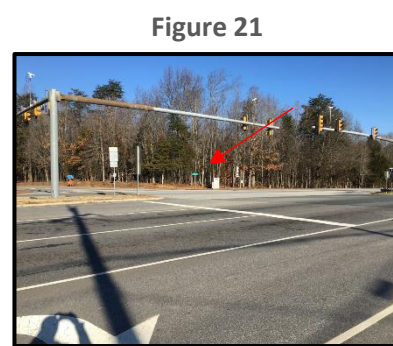
Figure 21

- Sign posts are provided on the northwest and northeast corners of the intersection for all approaching vehicles (**Figure 21**); however, no street sign panels are provided on the mast arms. (See *Recommendation A1*)
- The signal heads for all approaches have backplates but do not have yellow retroreflective borders installed. Based on the collision diagrams, rear-end and sideswipe crashes occurred in the past five years and could be due to poor visibility of the signal heads. (See *Recommendation A2*)

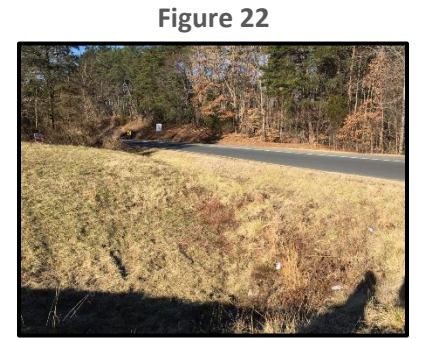
Figure 22

- A deep stormwater ditch exists on the southwest corner of the on-ramp to westbound US 460 from southbound Route 15 (**Figure 22**). Based on the collision diagrams, a non-collision crash occurred due to a vehicle making a wide right-turn and crashing into this ditch. (See *Recommendation A3*)

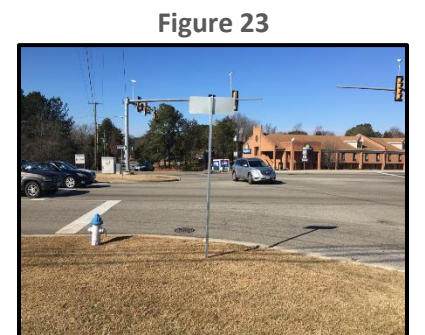
Figure 23

- Currently, southbound left-turning vehicles must yield to oncoming traffic when the protected green arrow is *not* provided. During the yield condition, northbound left-turn vehicles in the storage bay are obstructing the southbound left-turning vehicles' sight line of northbound through vehicles. Based on the collision diagrams, angles crashes were observed in 2013 and may be attributed to this obstruction. (See *Recommendation A7*)

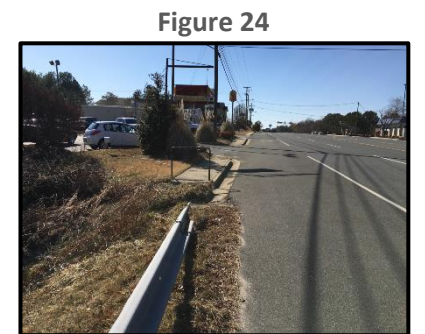
Figure 24

- A continuous sidewalk is provided on the west side of the road from Williams Street/Clark Street to Spring Valley Road; however, sidewalk discontinuity is present on the east side of this roadway segment (**Figure 24**). (See *Recommendation A8*)

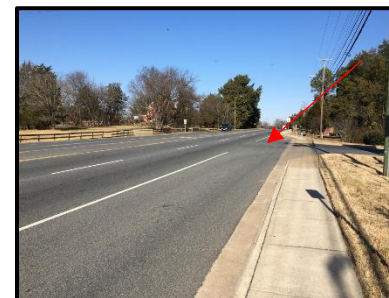
Figure 26

- The northbound rightmost lane at the Taco Bell driveway, located just north of the Belmont Circle/Peery Drive intersection, provides little indication that the lane is ending (Figure 26). (See Recommendation A15)

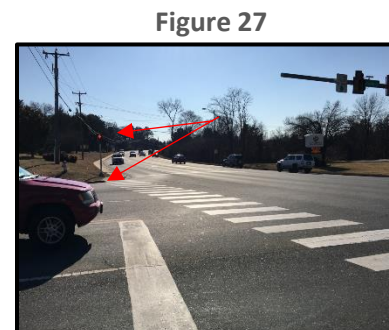
Figure 27

- The signals for all approaches have backplates but do not have yellow retroreflective borders installed. Based on the collision diagrams, rear-end crashes occurred in 2013-2014 and in 2017 and could be due to poor visibility of the signal heads. (See Recommendation A17)
- The eastbound approach pavement markings are faded. (See Recommendation A18)
- Pedestrian facilities (e.g., crosswalks and pedestrian signals) exist across the north and east legs of the intersection; however, the existing ramps and tactile domes are non-ADA compliant and the pedestrian signals are outdated (i.e., pedestrian countdown timer is not provided) (Figure 27). In addition, there is no sidewalk on the west side of the roadway; therefore, the intersection

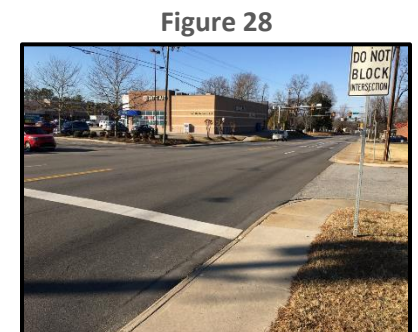
Figure 28

- The pavement markings are faded on the eastbound approach of the intersection, and there are no pavement markings (i.e., stop bar, pavement arrows) on the westbound approach. (See Recommendation A23)
- There are no street signs provided for any of the approaches at the intersection (Figure 28). (See Recommendation A24)
- No pedestrian crosswalks are provided on the east and west sides of the intersection. Additionally, the northeast and southeast corners do not provide pedestrian ramps. (See Recommendation A25)

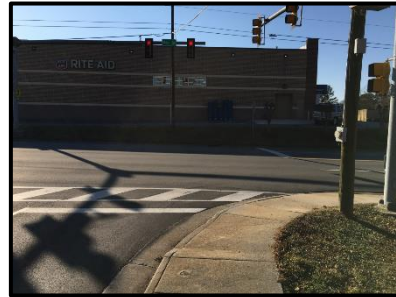
Figure 30

- Currently, no “Turning Vehicles Yield to Pedestrians” sign panels (R10-15) are provided for the northbound, southbound, and westbound approaches (Figure 30). (See Recommendation A29)

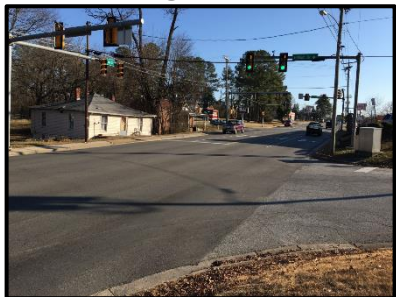
Figure 31

- The Gilliam Drive intersection is located approximately 150 feet north of the Reed Street intersection, which does not comply with the distance separation between two signalized intersections (Figure 31), outlined in Table 2-2 of VDOT Road Manual Appendix F. Based on the crash diagrams, rear-end crashes were prominent from 2013 through 2017, along the northbound and southbound lanes. The proximity issues of these two intersections could be attributing to these crash statistics. (See Recommendation A30)

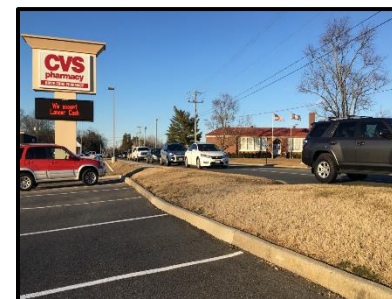
Figure 33

- During the PM peak hour, vehicles queues were observed extending back along the eastbound approach right-turn lane. These vehicle queues blocked vehicles from accessing the eastbound left turn pocket lane (Figure 33). Additionally, during the PM peak hour, vehicles were observed unable to proceed through the eastbound phase in one cycle.

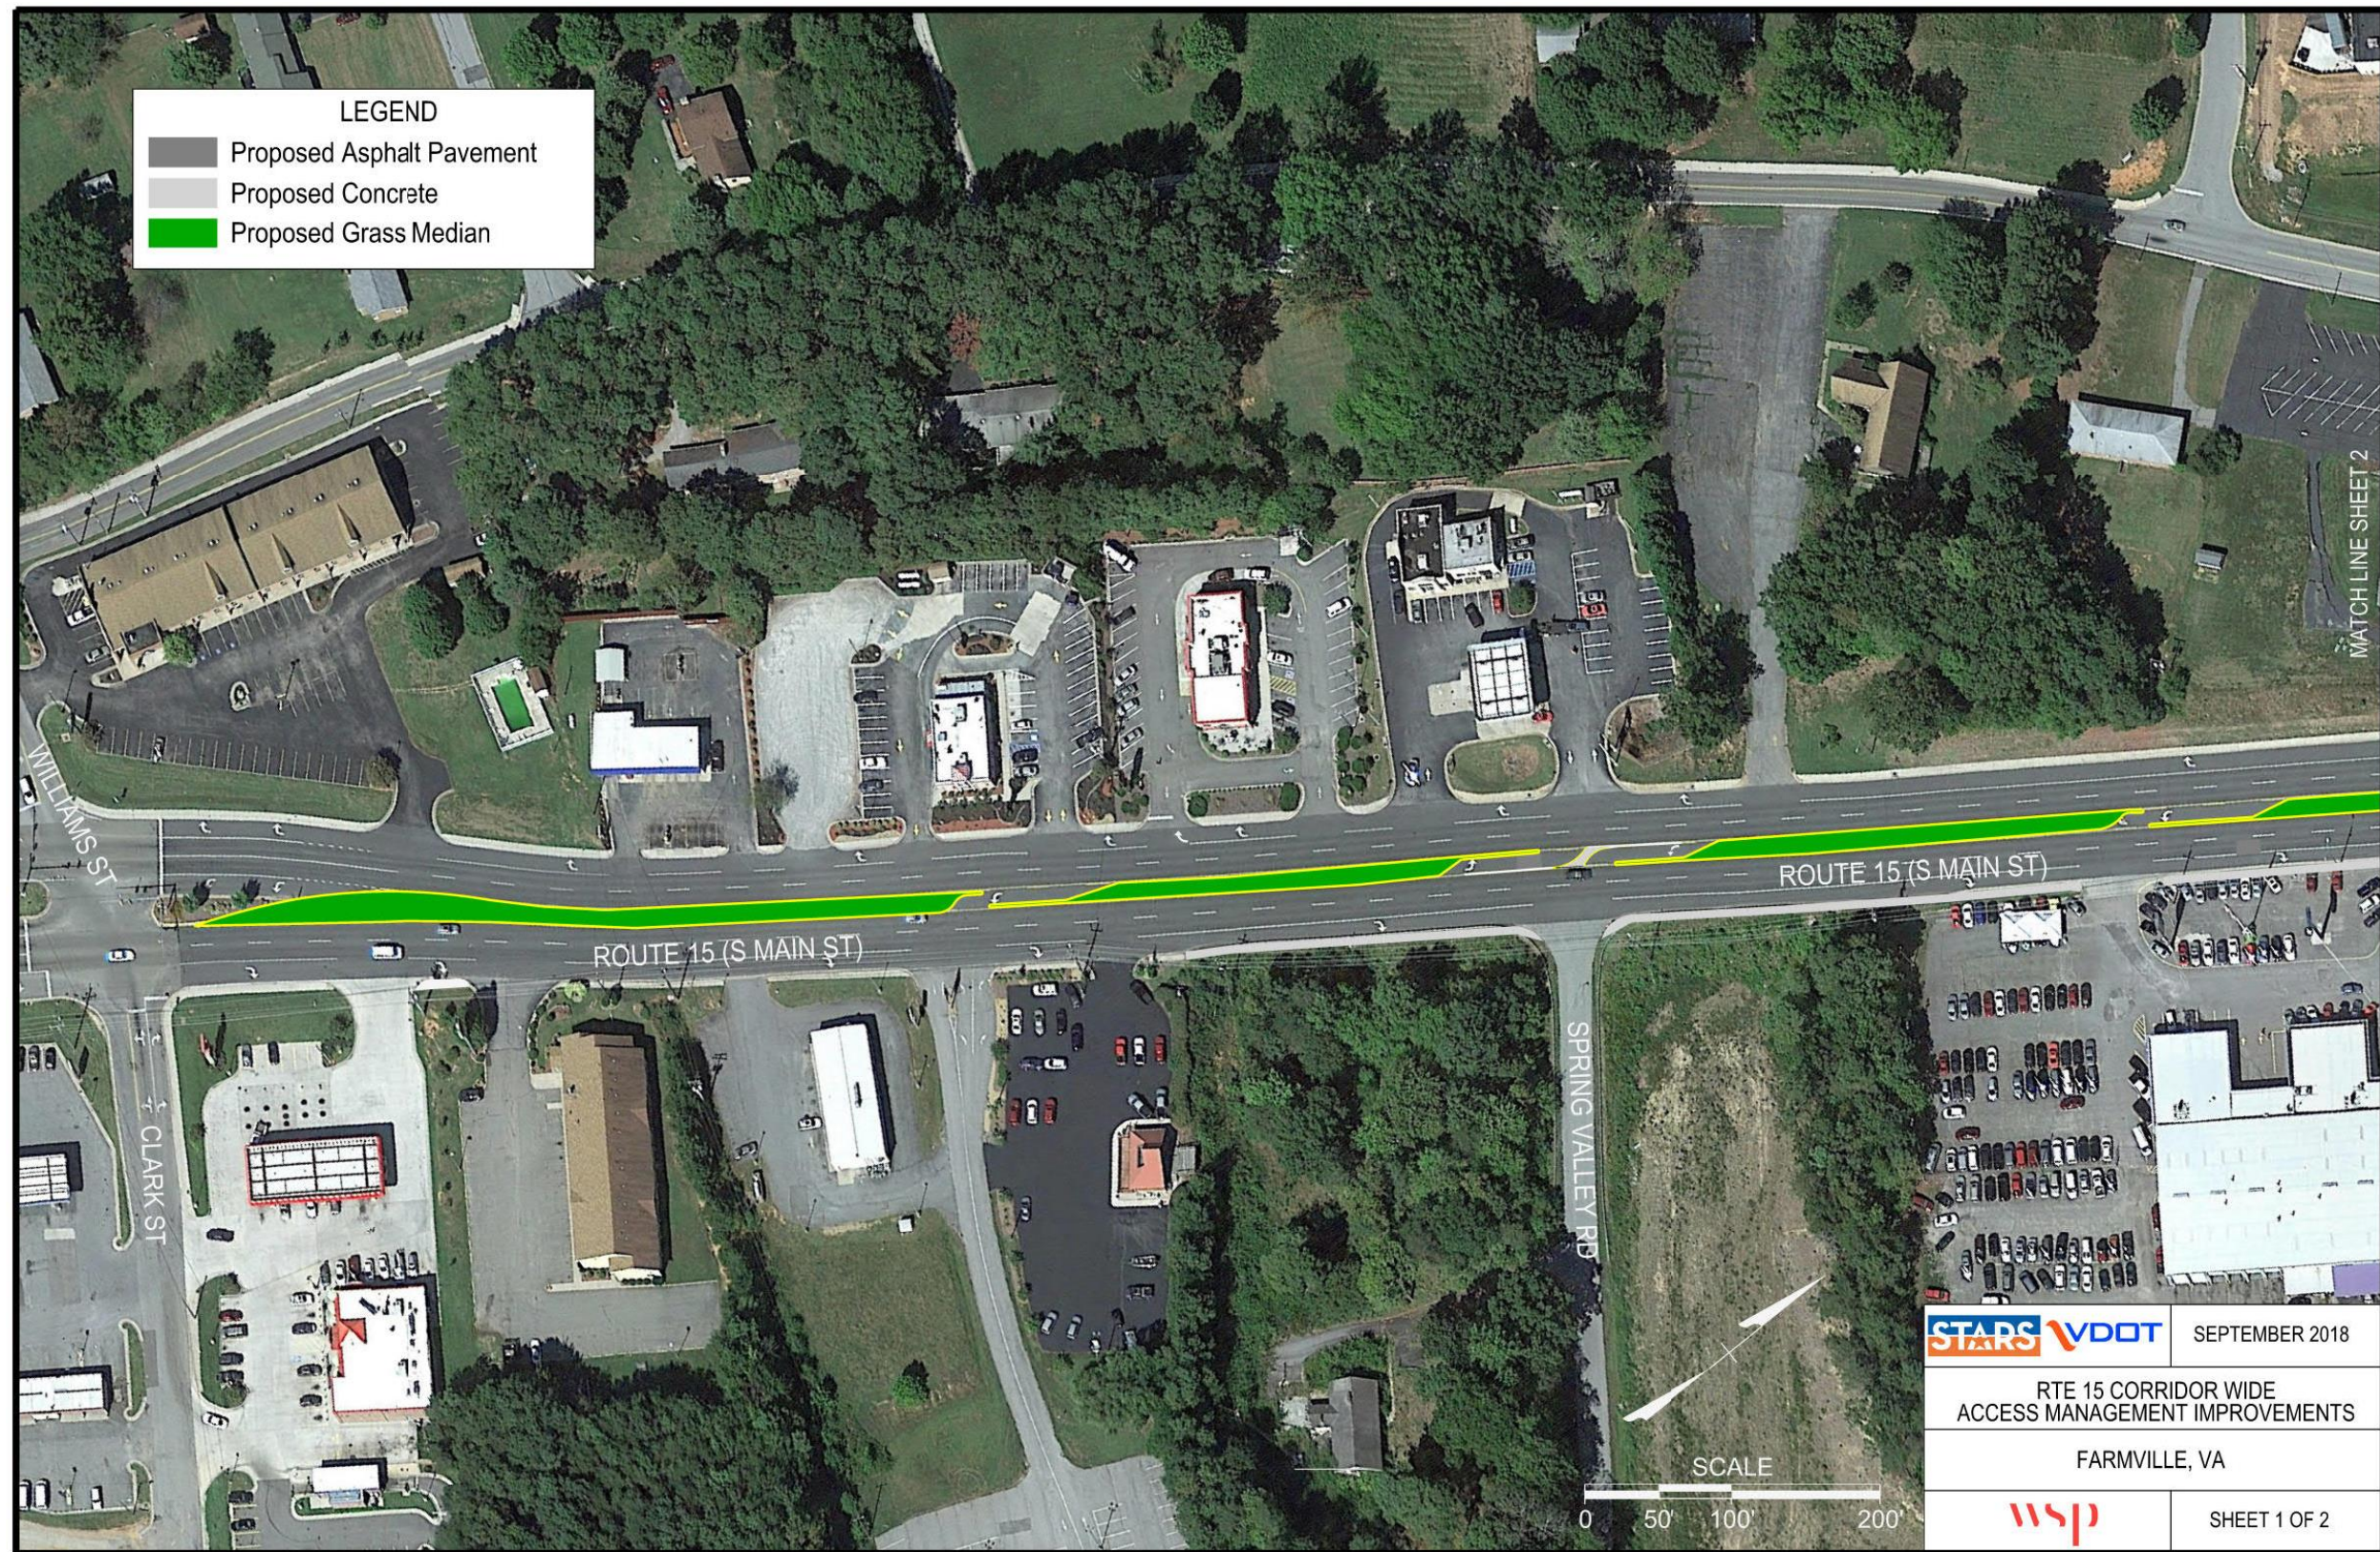
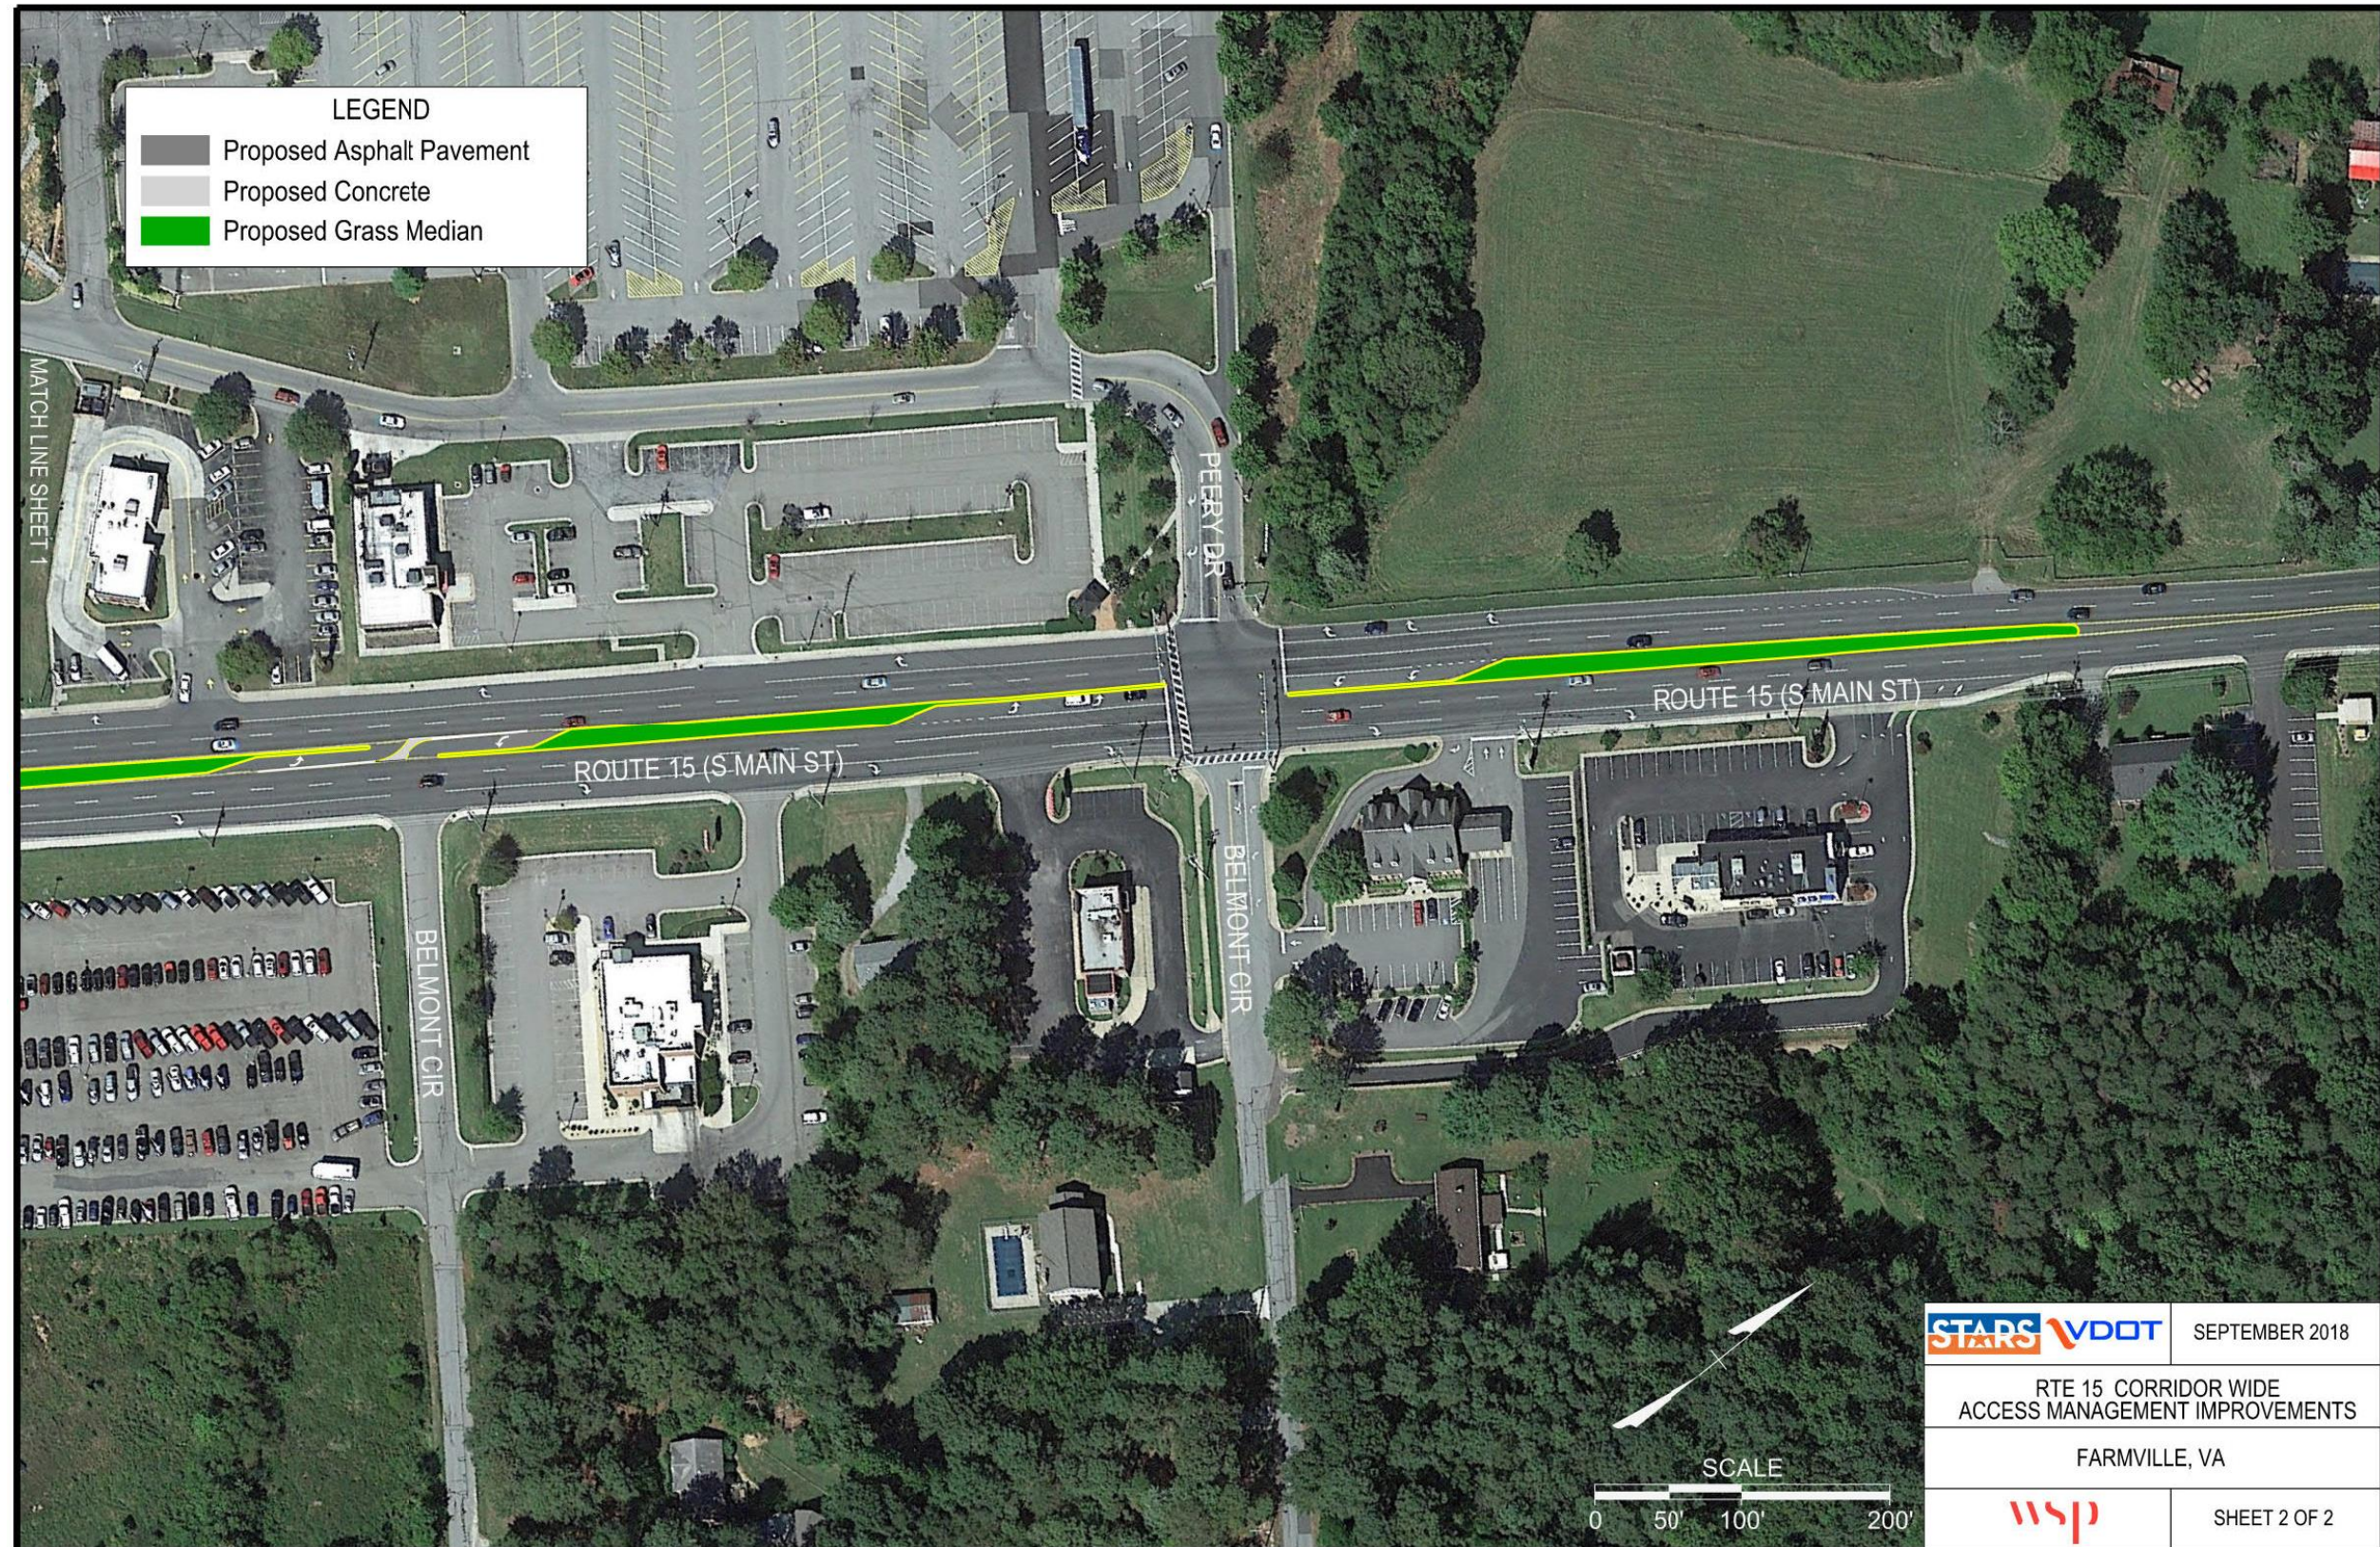
Figure 39. Alternative 5 Conceptual Layout (Corridor-Wide Improvement)

Figure 39 (Continued). Alternative 5 Conceptual Layout (Corridor-Wide Improvement)
