Application Summary

Project Narrative Bridge No. 00003 (000-1046) Old Glebe Road over Route 120 Bridge

Executive Summary	1
Project Background	2
Existing Conditions	
Alternatives Considered	5
Roadway	13
Pedestrian Accomodation	13
Right of Way	13
Utility	14
Environmental Considerations	18
Design Exceptions and Design Waivers	19
Recommendation	19

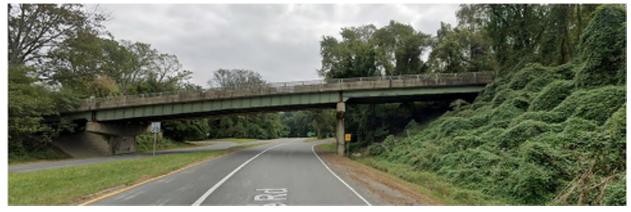
The Old Glebe Road Bridge is a three-span (simple spans) steel multi-girder structure supported on reinforced concrete abutments and two hammerhead piers. The total bridge length is 213'-6" consisting of a 102'-6" long center span, 71'-0" long south span and 38'-0" long north span. The bridge width is 32'-8", consisting of two 12'-0" wide lanes, a 5-foot wide sidewalk on the east side, 1'-6" wide curb one the west side, and there are 1'-0" wide barriers with railings on each side of the bridge. It should be noted that the approach roadway has a sidewalk on both sides.

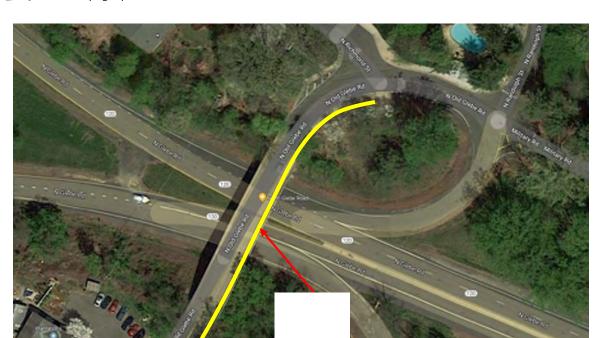
Figure 1 - Old Glebe Road over Route 120 Bridge Aerial View

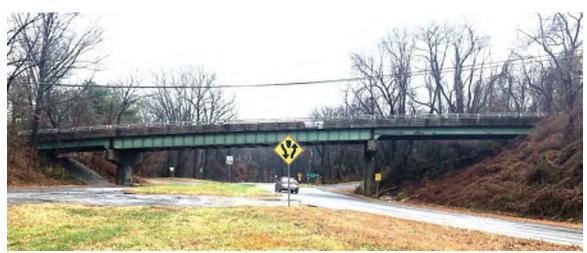
Figure 2 – Elevation View of Existing Structure Looking East

The total bridge length is 213'-6" consisting of a 102'-6" long center span, 71'-0" long south span and 38'-0" long north span. The bridge width is 32'-8", consisting of two 12'-0" wide lanes, a 5-foot wide sidewalk on the east side, 1'-6" wide curb one the west side, and there are 1'-0" wide barriers with railings on each side of the bridge. It should be noted that the approach roadway has a sidewalk on both sides. The bridge deck, based on the August 2019 inspection report, has a GCR (General Condition Rating) of 4 which makes the deck repair/replacement eligible for SGR funding. GCR for superstructure is 6 and for substructure is 5 based on latest bridge inspection report.

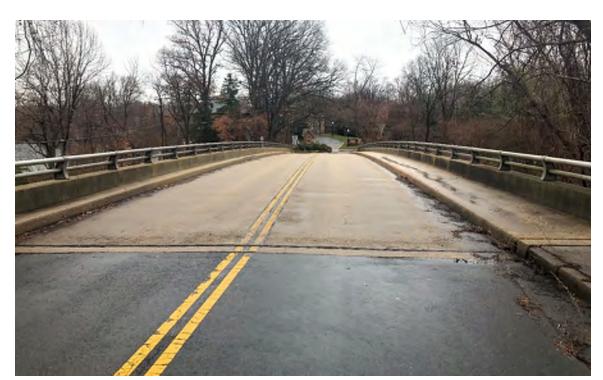
Figure 3 – Existing Structure Looking North

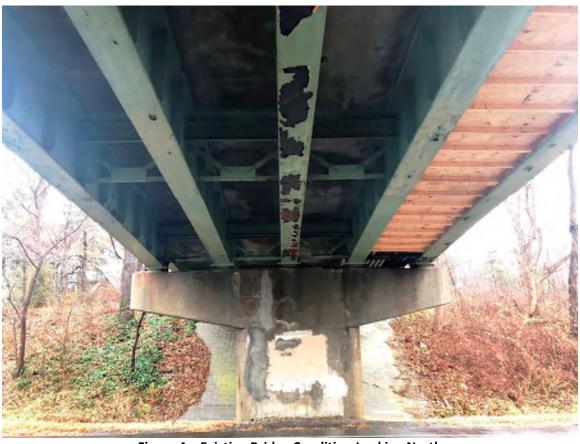
Figure 4 – Existing Bridge Condition Looking North

Deck: The condition rating of the Deck is 4 (Poor Condition) due to longitudinal and transverse cracks up to 1/8" wide, delaminations, potholes and edge spalls on deck wearing surface. The deck is upto 1/2" higher than abutment backwall in Span 1. The underside of the deck exhibits several spalls and delaminations.

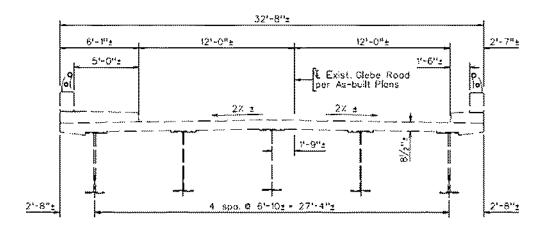
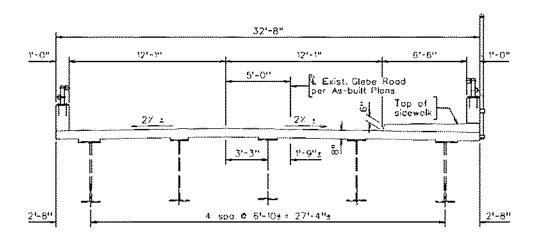
TYPICAL EXISTING BRIDGE CROSS SECTION

PROPOSED BRIDGE CROSS SECTION

Figure 5 – Alternative 1: Deck Replacement (Looking south)

This alternative consists of full deck replacement and rehabilitation of existing superstructure and substructure. A 6' wide sidewalk will be provided on the west wide of the proposed deck, which necessitates shifting roadway baseline. Minimum one lane of traffic will be maintained during deck replacement and repair. Bridge rehabilitation will include joint closure over the piers and abutments.

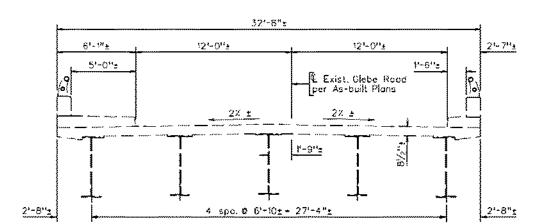
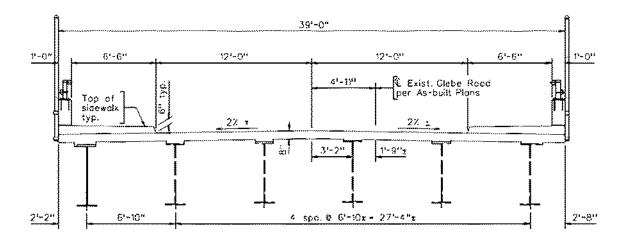
TYPICAL EXISTING BRIDGE CROSS SECTION

PROPOSED BRIDGE CROSS SECTION

Figure 6 – Alternative 2: Deck Replacement with Bridge Widening (Looking south)

This alternative consists of full deck replacement, widening the bridge on the east side to accommodate 6' sidewalks on both sides of the structures, and rehabilitation of existing superstructure and substructure. Minimum one lane of traffic will be maintained during deck replacement and repair. Bridge rehabilitation will include joint elimination over the piers and abutments.

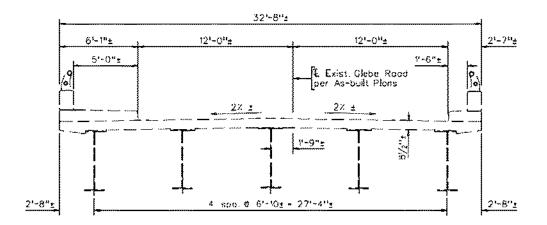
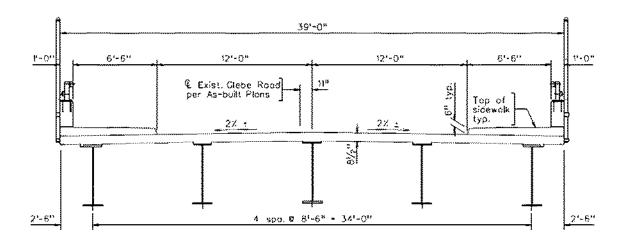
TYPICAL EXISTING BRIDGE CROSS SECTION

PROPOSED BRIDGE CROSS SECTION

Figure 7 – Alternative 3: Full Bridge Replacement – ABC (Looking south)

This alternative consists of full replacement of the existing structure with a single span bridge. Proposed full integral abutments will be constructed behind the existing piers and Accelerated Bridge Construction (ABS) will be utilized to remove the existing structure and erect the proposed superstructure and approach slabs to minimize road closure and traffic impact. Proposed structure will include two lanes of traffic and 6' wide sidewalk on both sides of the structure, and it will require approach roadway widening on east side of the existing bridge to accommodate the additional sidewalk.

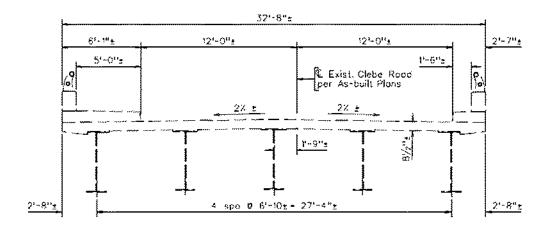
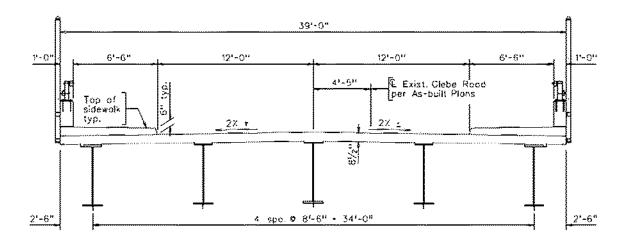
TYPICAL EXISTING BRIDGE CROSS SECTION

PROPOSED BRIDGE CROSS SECTION

Figure 8 - Alternative 4: Full Bridge Replacement - Staged Construction (Looking south)

This alternative consists of full replacement of the existing structure with a single span bridge using staged construction. Proposed structure will include two lanes of traffic and 6' wide sidewalk on both sides of the structure and it will require approach roadway widening on east side of the existing bridge to accommodate the additional sidewalk. Minimum one lane of traffic will be maintained during staged construction.

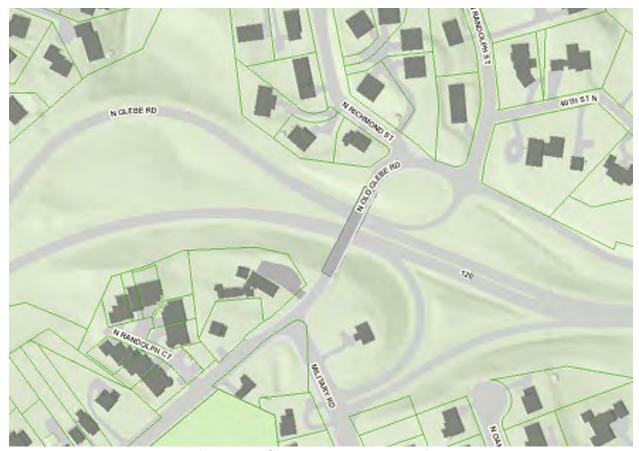
Figure 9 - Arlington County Property Lines

Based on Arlington County property map, ROW lines on the property on the south-east side of the bridge is not clear. Due to anticipated utility relocation and impact, ROW is anticipated for all alternatives. Additionally, due to guardrail and MASH requirements, ROW may be required for approach roadway work. Once the topographic, utility and right-of-way lines are surveyed, ROW and easement impacts will be evaluated.

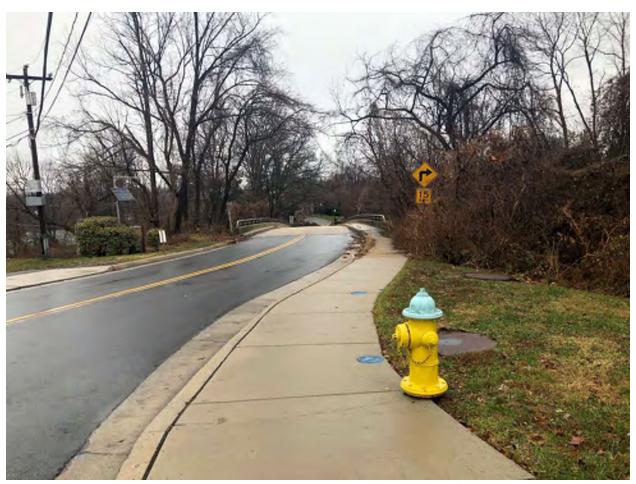
Figure 10 – Underground Utilities on South-East Corner of the Bridge

There are several additional utilities including water, sewer, gas, communication cables and OH power line, near the existing structure, some of which will be impacted by improving the bridge and approach roadways. Of particular note is a gas monitoring station located near the southwest corner of the bridge. The risk associated with the unknown details of these utilities has been documented in the risk assessment (Appendix A2) and the contingencies have been adjusted accordingly in the cost estimates (Appendix A3).

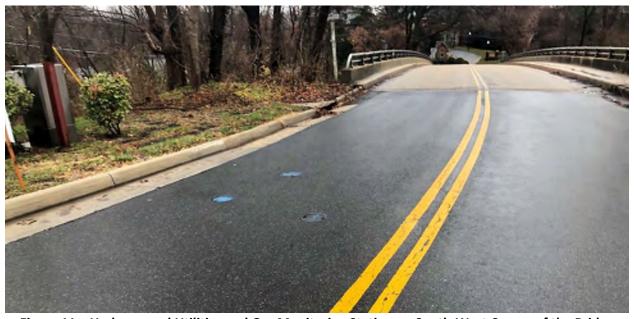
Figure 11 – Underground Utilities and Gas Monitoring Station on South-West Corner of the Bridge

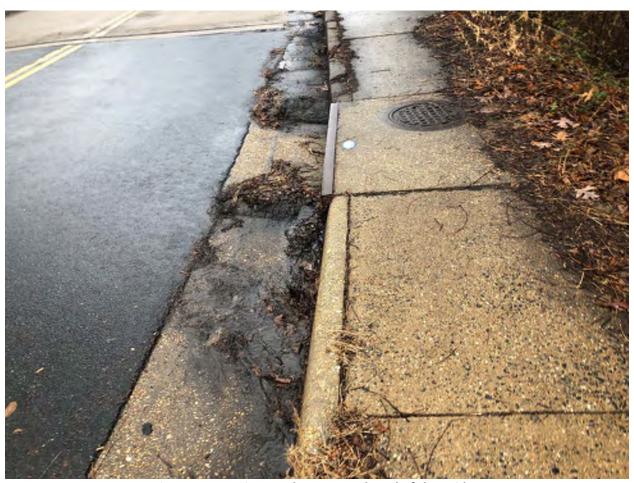
Figure 13 – Drainage Inlets on South End of the Bridge

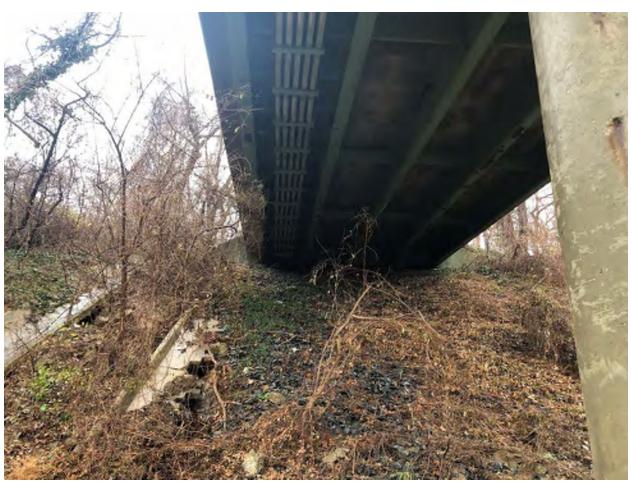
Figure 14 – Utility Conduits Supported by the Existing Superstructure

- Provide temporary support for the utility conduits during the construction and replace damaged and deteriorated utility conduits and attachments.
- Install pedestrian fence on west side of the proposed deck.

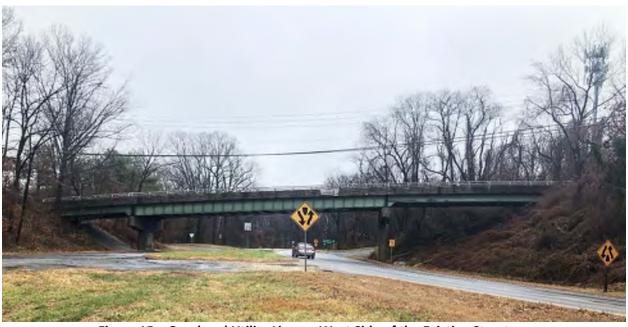
Figure 15 – Overhead Utility Line on West Side of the Existing Structure

There is an overhead utility line over Route 120 and parallel to the existing structure, approximately 70' on the west side of the existing bridge, as well as overhead utility lines crossing over Old Glebe Road approximately 25' from both ends of the bridge. Deck replacement and other repair for Alternative 1 can be completed within safe distance of the existing utility lines. For Alternative 3, de-energizing the overhead utility line on the west side of the existing bridge may be required during construction. Underground utility investigation is required for the substructure widening for alternatives 2, 3 and 4.

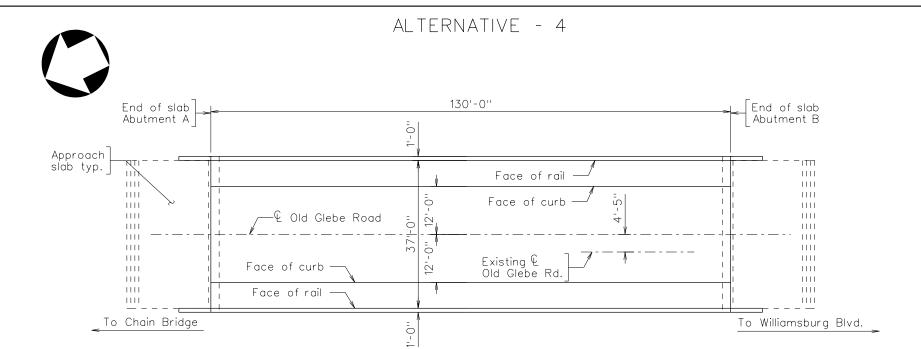
ALTERNATIVE - 4

PROPOSED BRIDGE PLAN

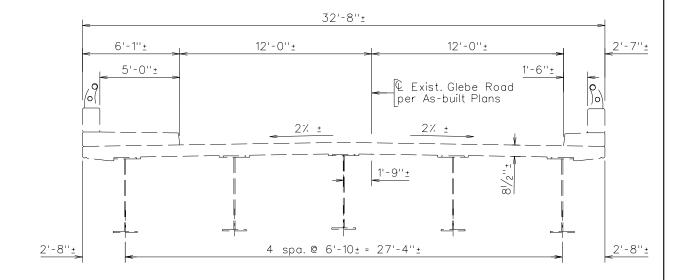
TYPICAL EXISTING BRIDGE CROSS SECTION

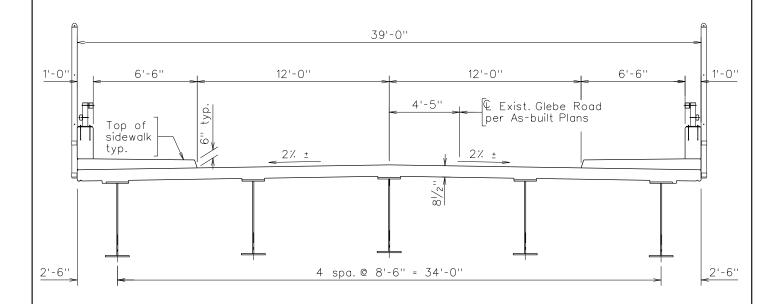
PROPOSED BRIDGE CROSS SECTION

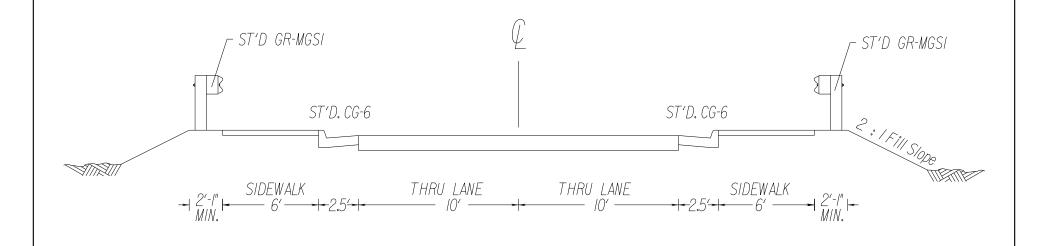
PROPOSED ROADWAY CROSS SECTION
